Pawtuckaway Lake Dams

Pawtuckaway Lake Improvement Association

Corey Clark – Chief Engineer

New Hampshire Department of Environmental Services

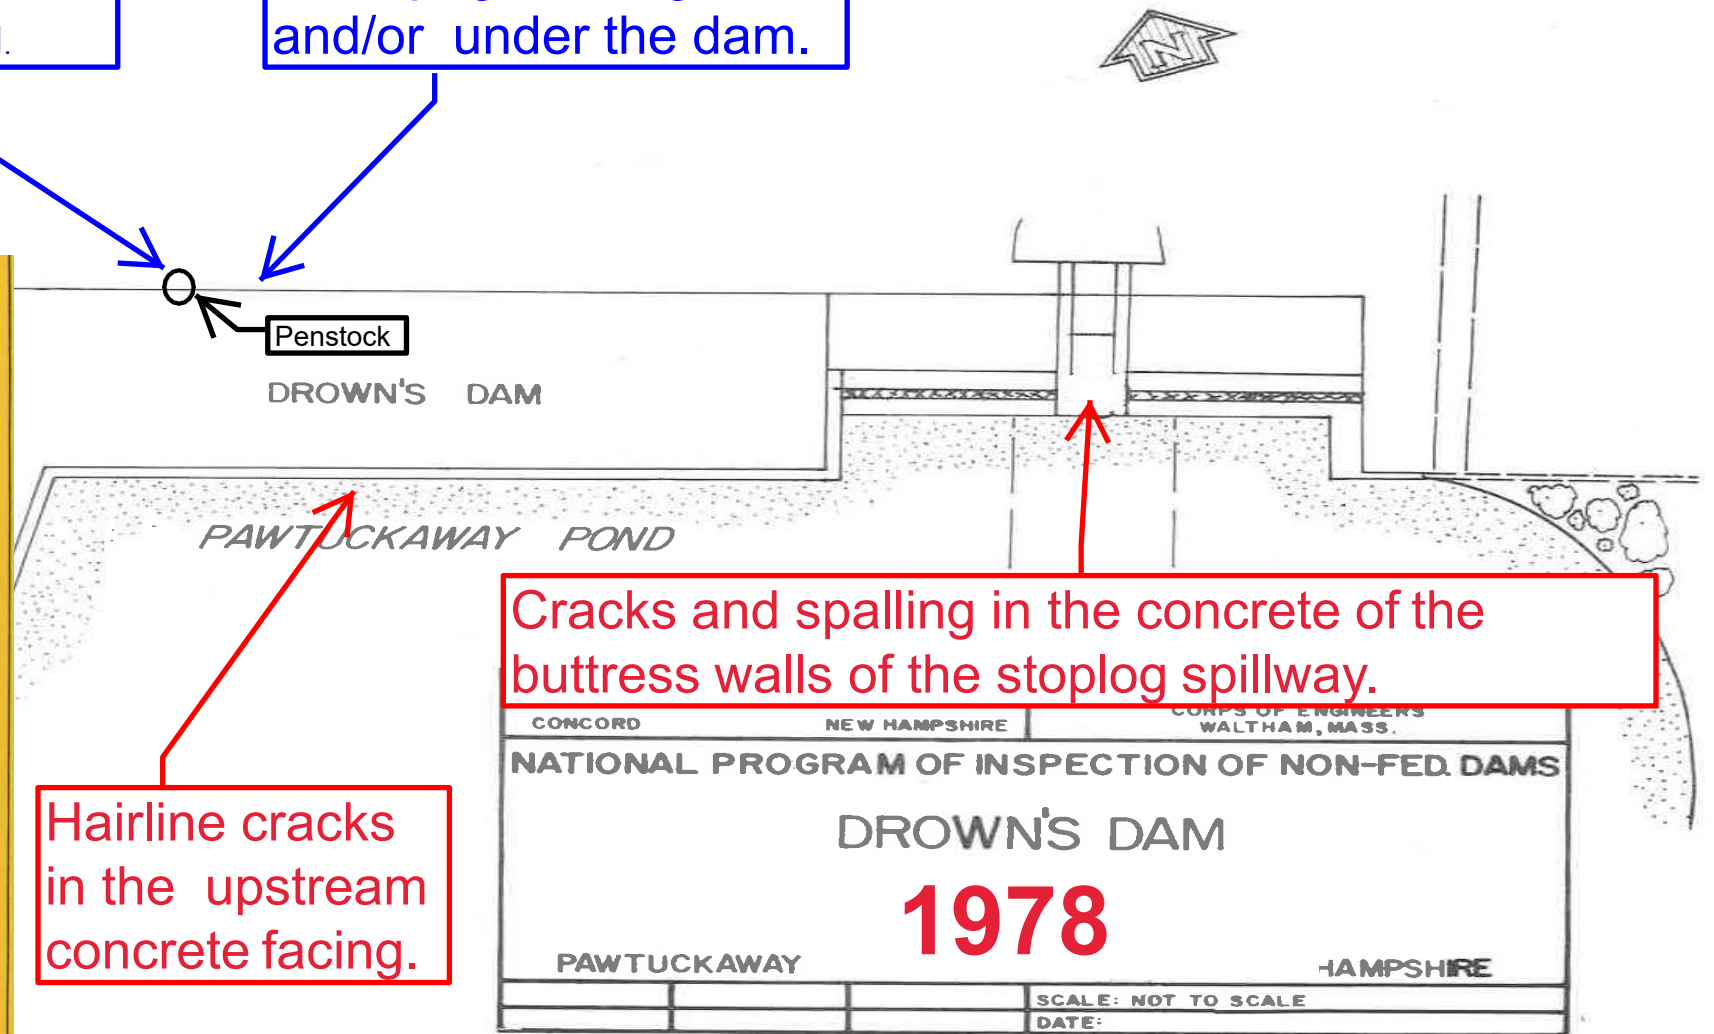
Hairline cracks
in the upstream
concrete facing.

Cracks and spalling in the concrete of the
buttress walls of the stoplog spillway.

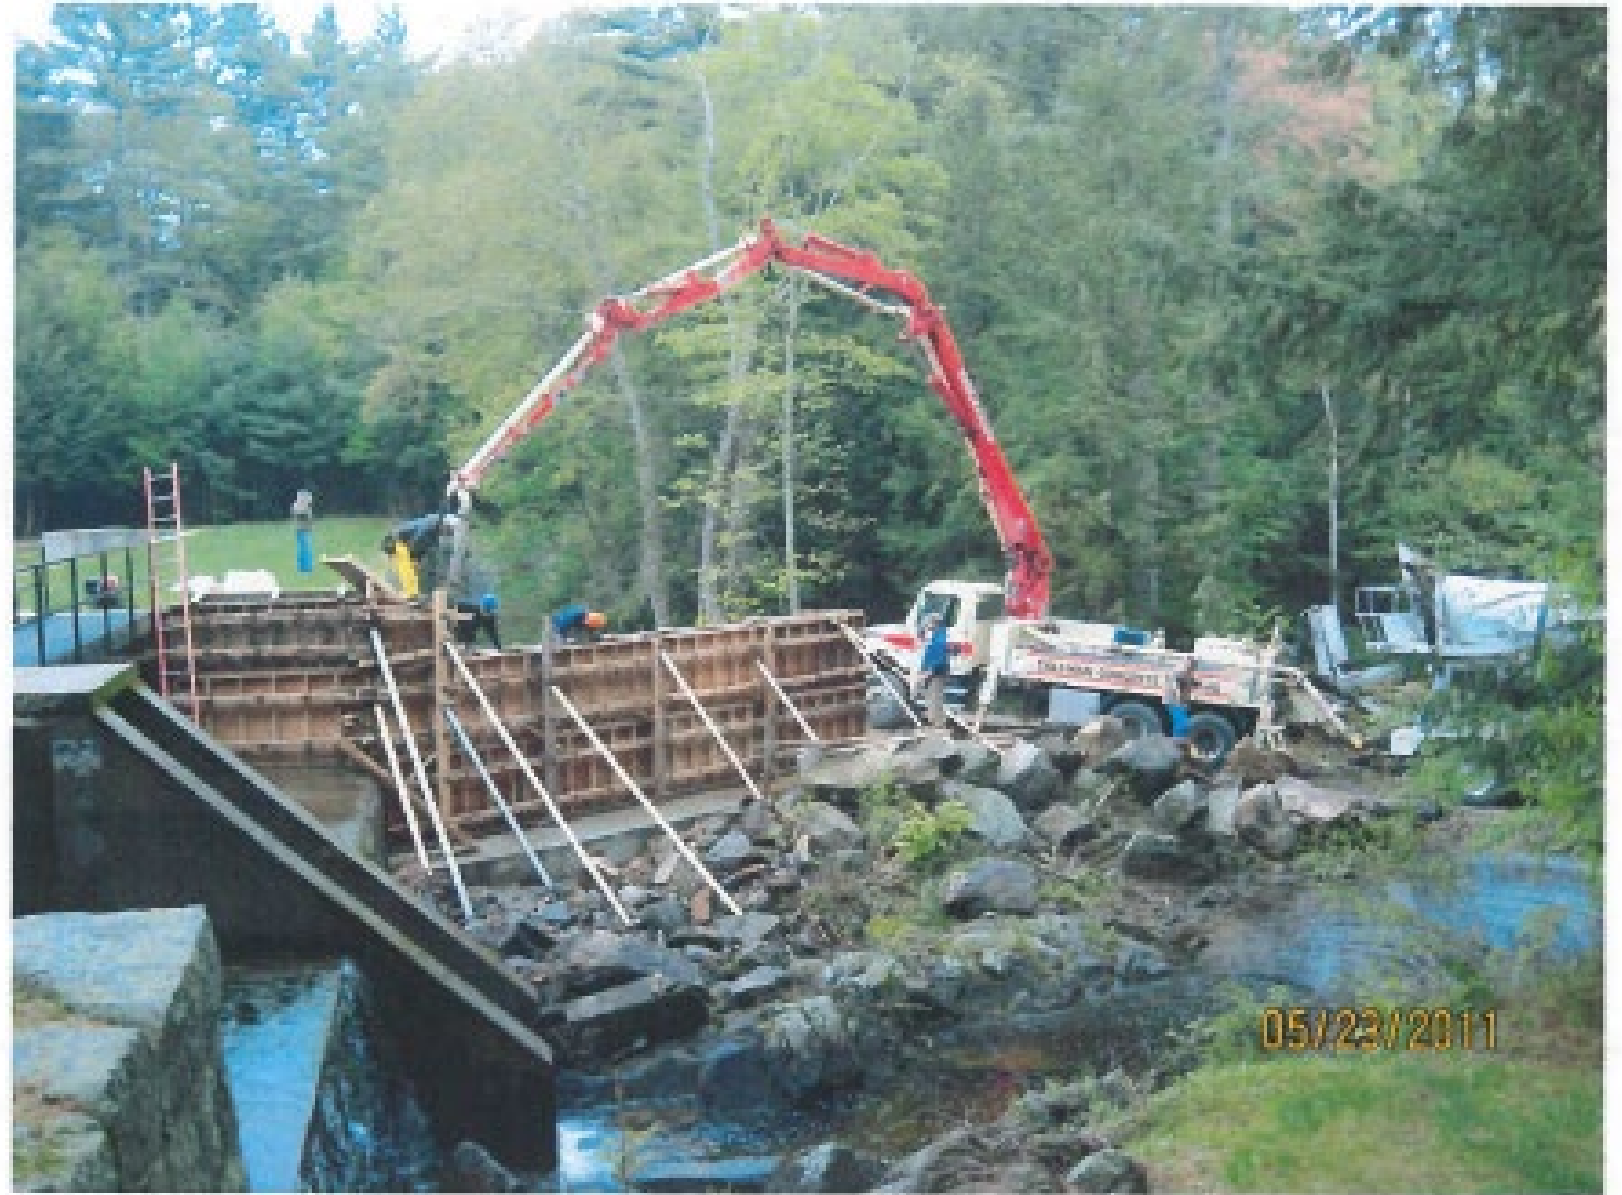
Photograph 5 – Concrete pumper truck used for wall pour.

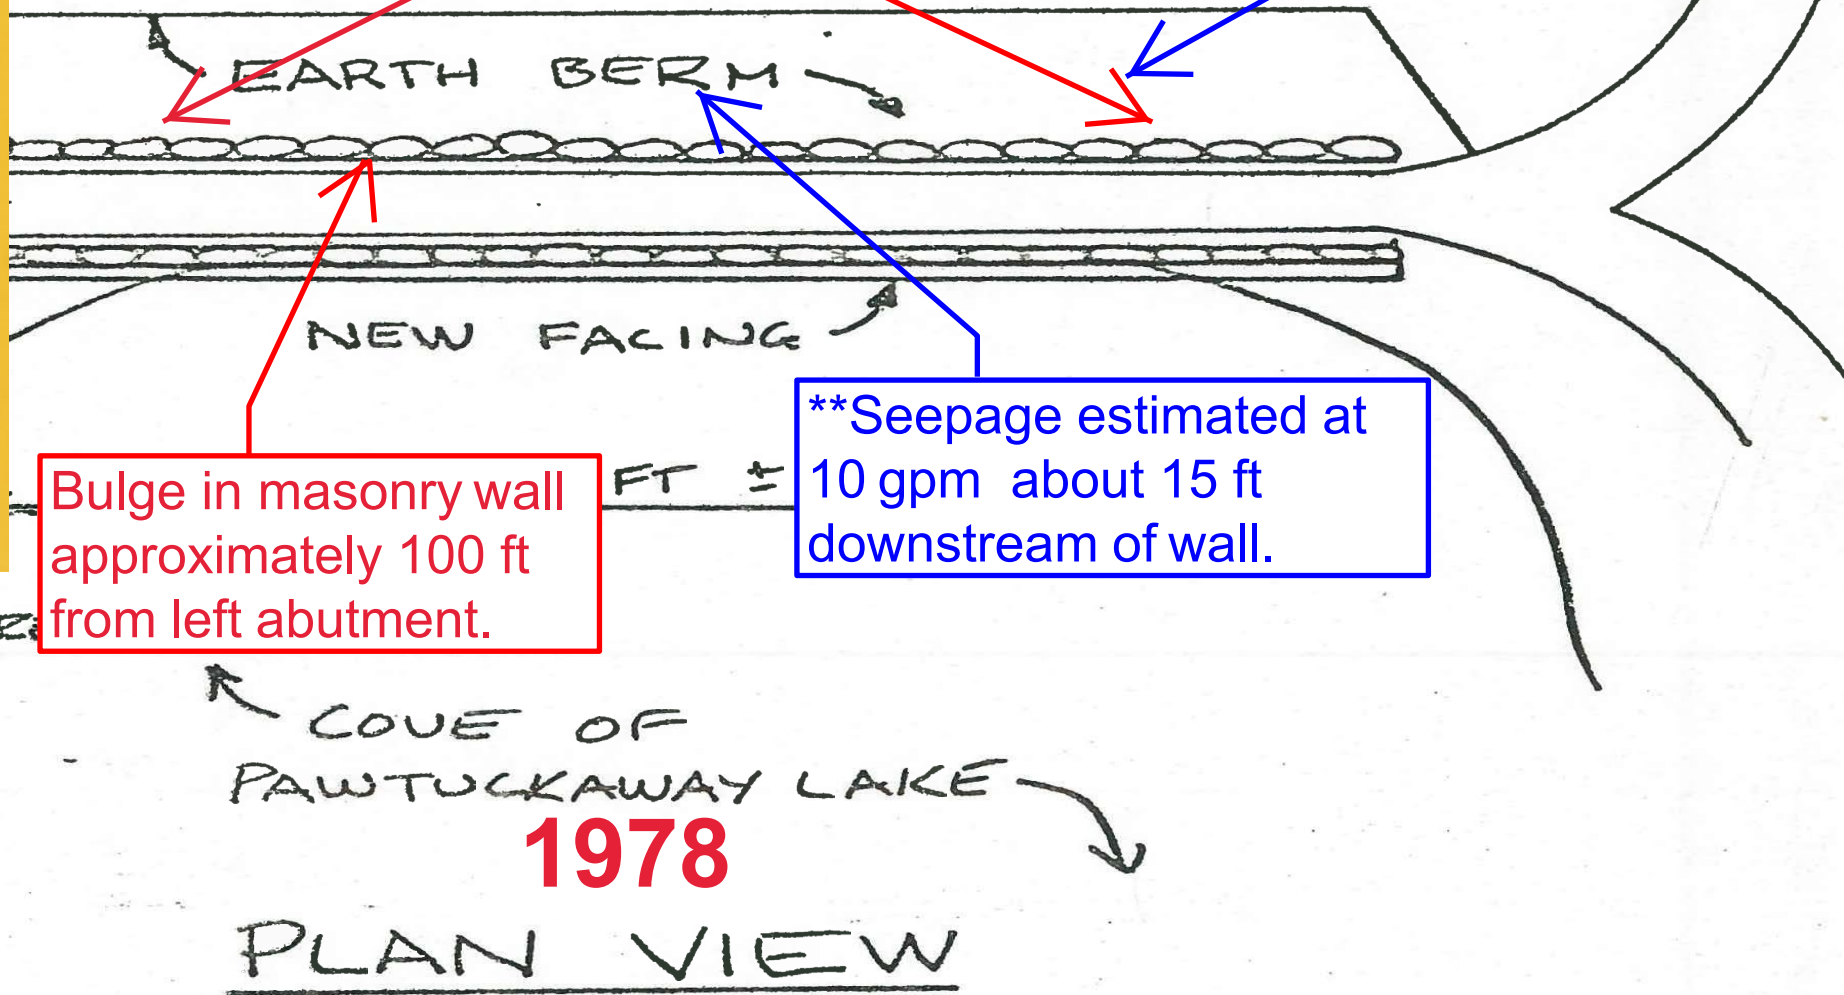
PLAN VIEW

"Numerous" large boulders were
dumped immediately downstream of
the dike on both sides.

Seepage and
standing water
visible
downstream of
right abutment.

Bulge in masonry wall
approximately 100 ft
from left abutment.

**Seepage estimated at
10 gpm about 15 ft
downstream of wall.

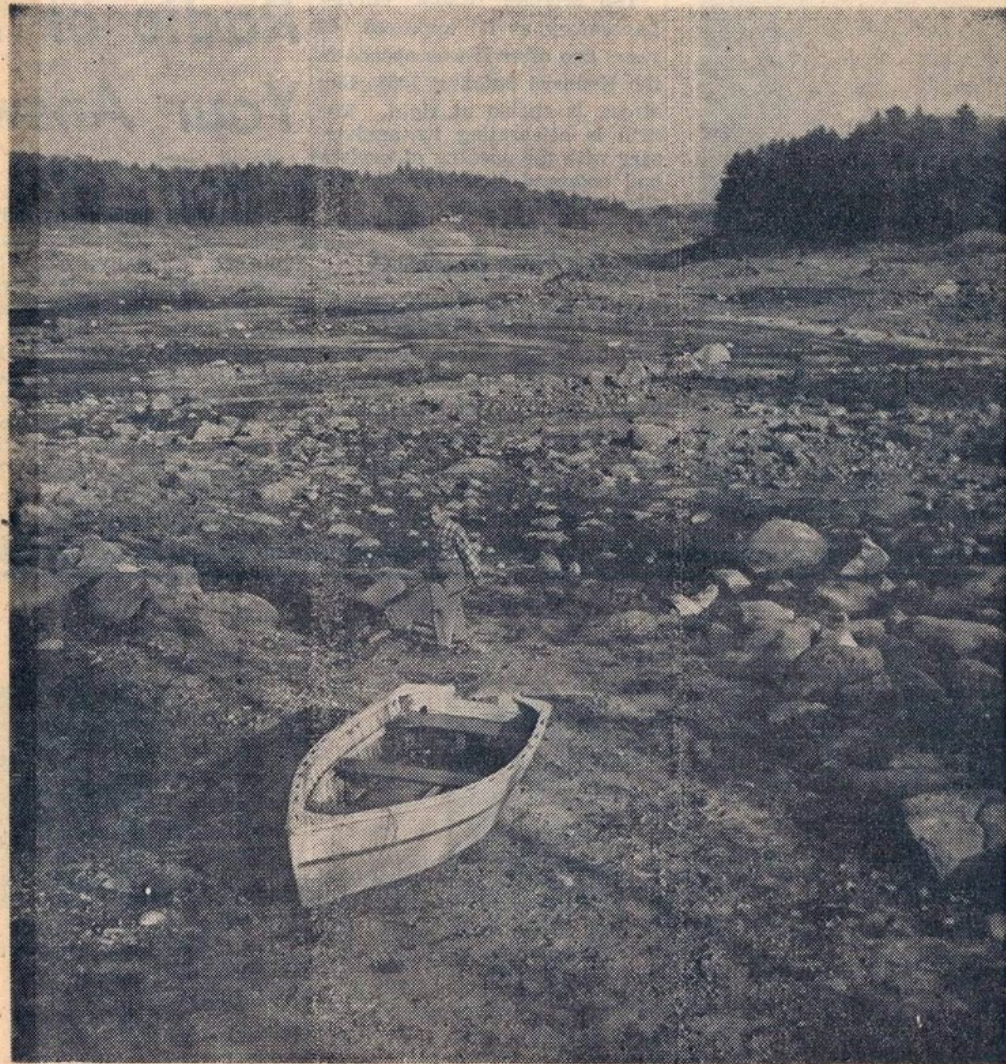
PAWTUCKWAY POND (above) looks like barren wasteland this weekend but, electric company officials say, this is the last time it will appear in such condition. After repairs to the dam, the firm has agreed to maintain a 10-foot winter and 18-foot summer water level. Hans Brustle, local resident, is working with his wheelbarrow where he would ordinarily be fishing from his row boat.

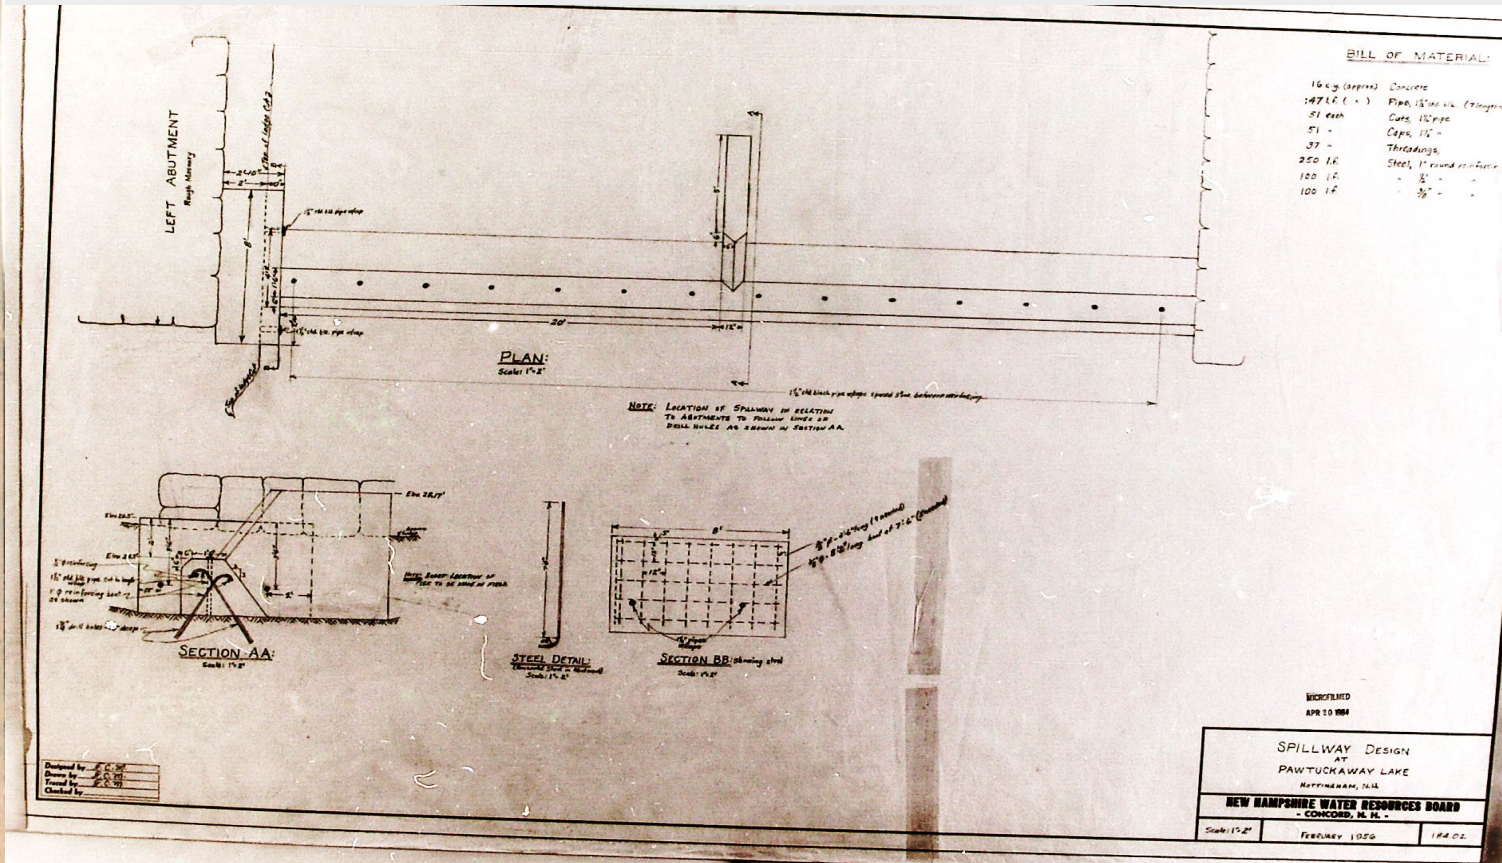
Dolloff Dam Spillway Reconstruction (1956)

154 cubic yards of ledge blasted from spillway to increase capacity

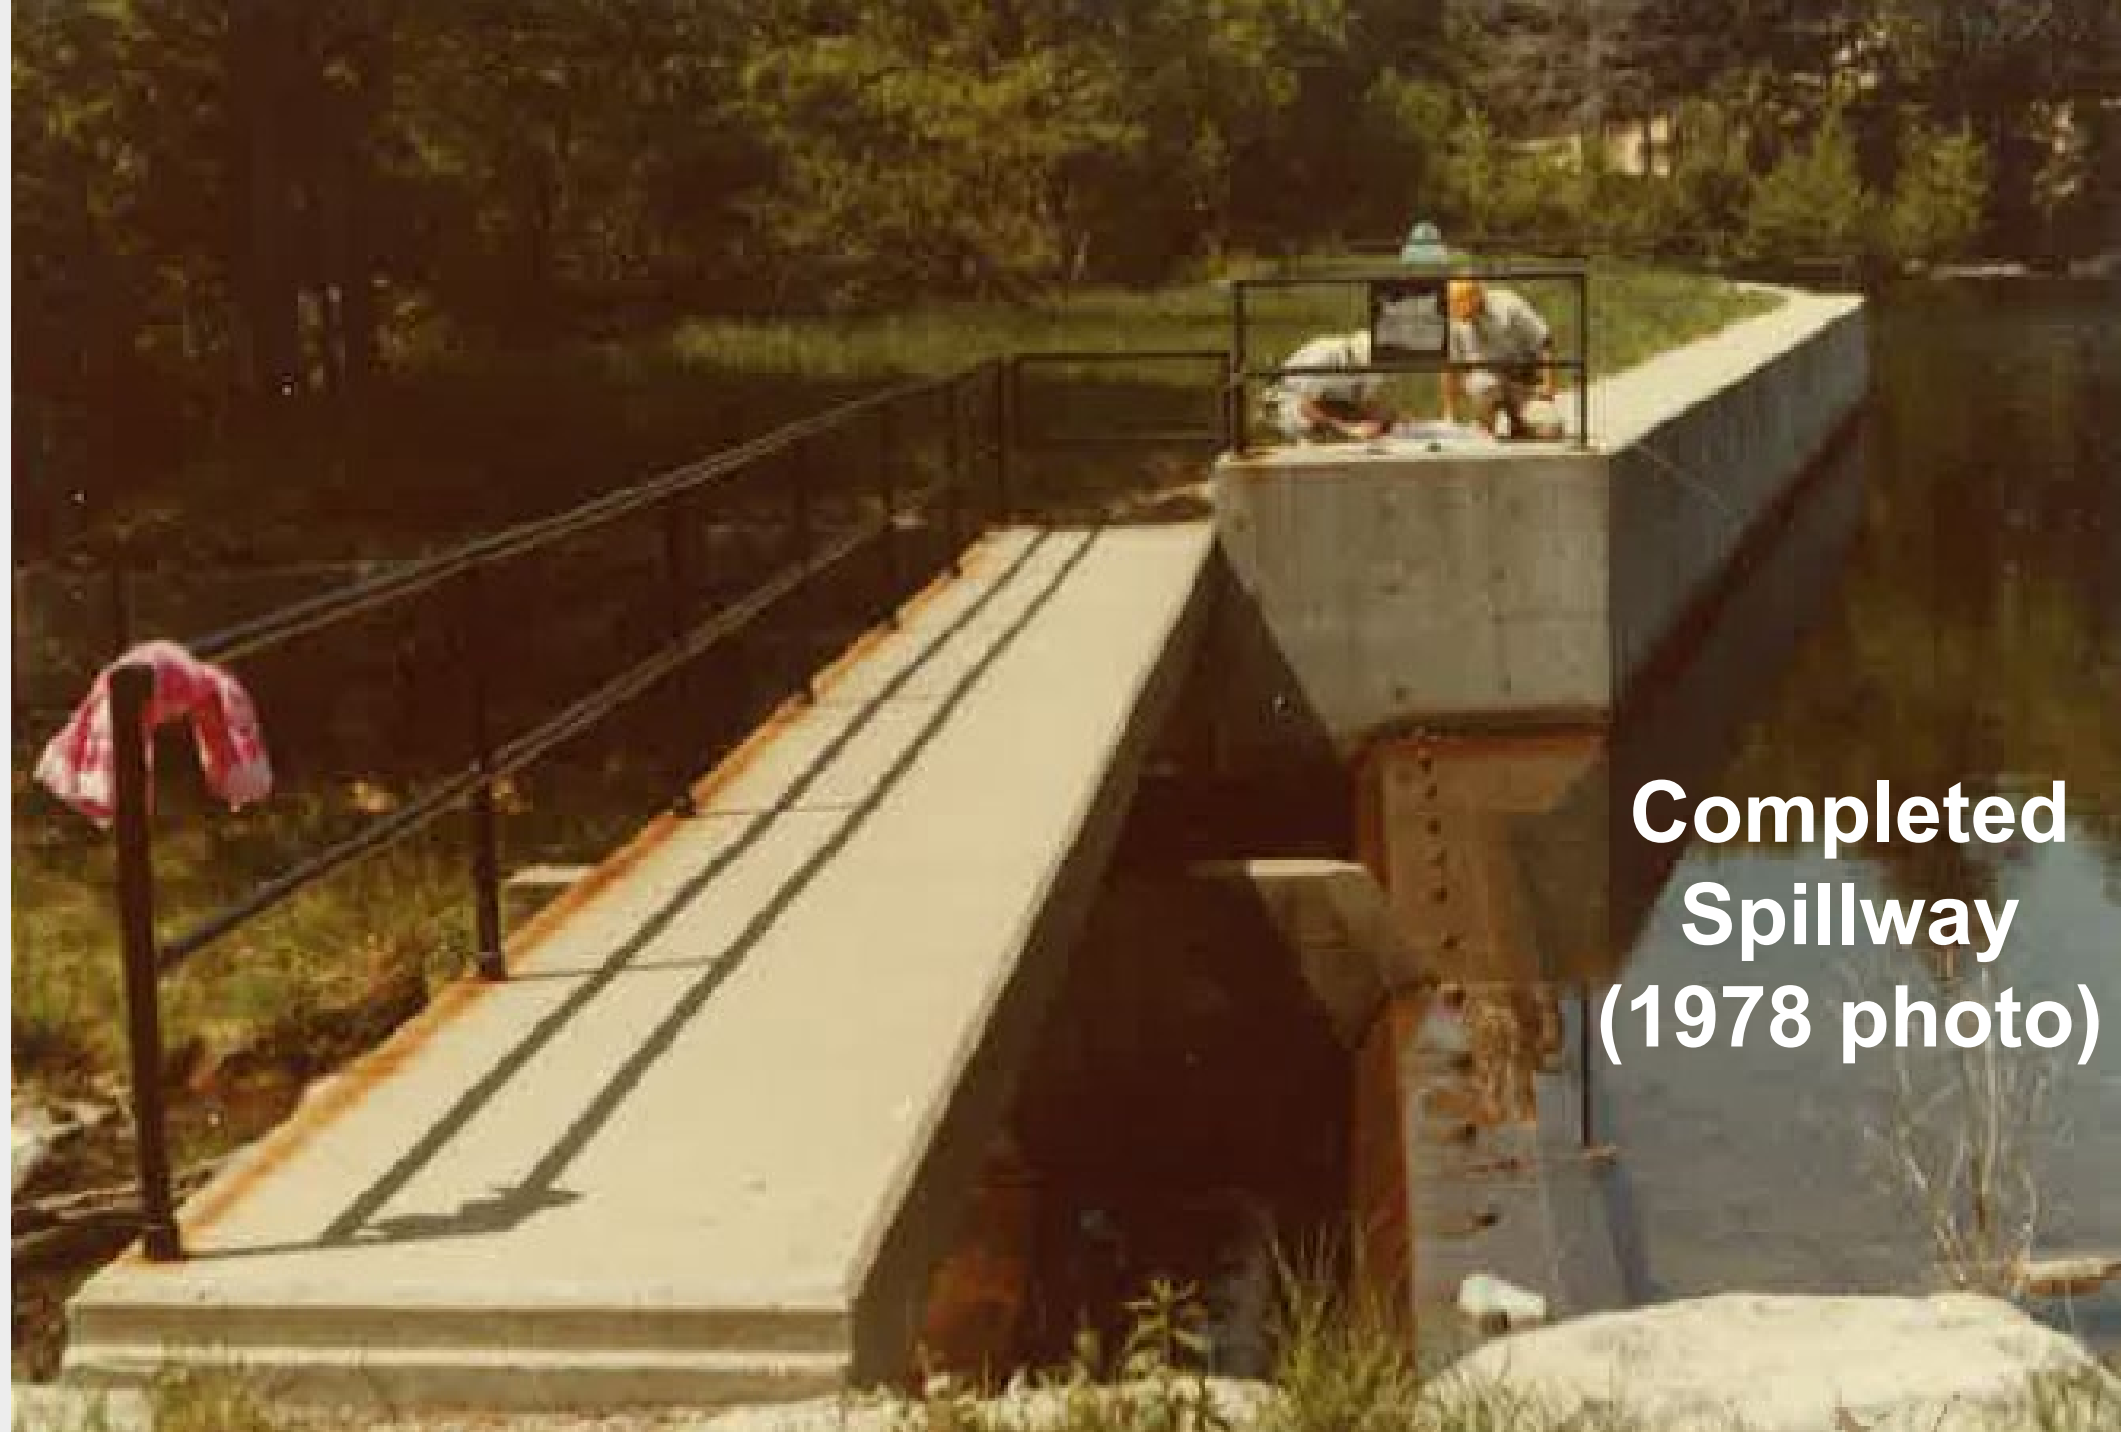
**Completed
Spillway
(1978 photo)**

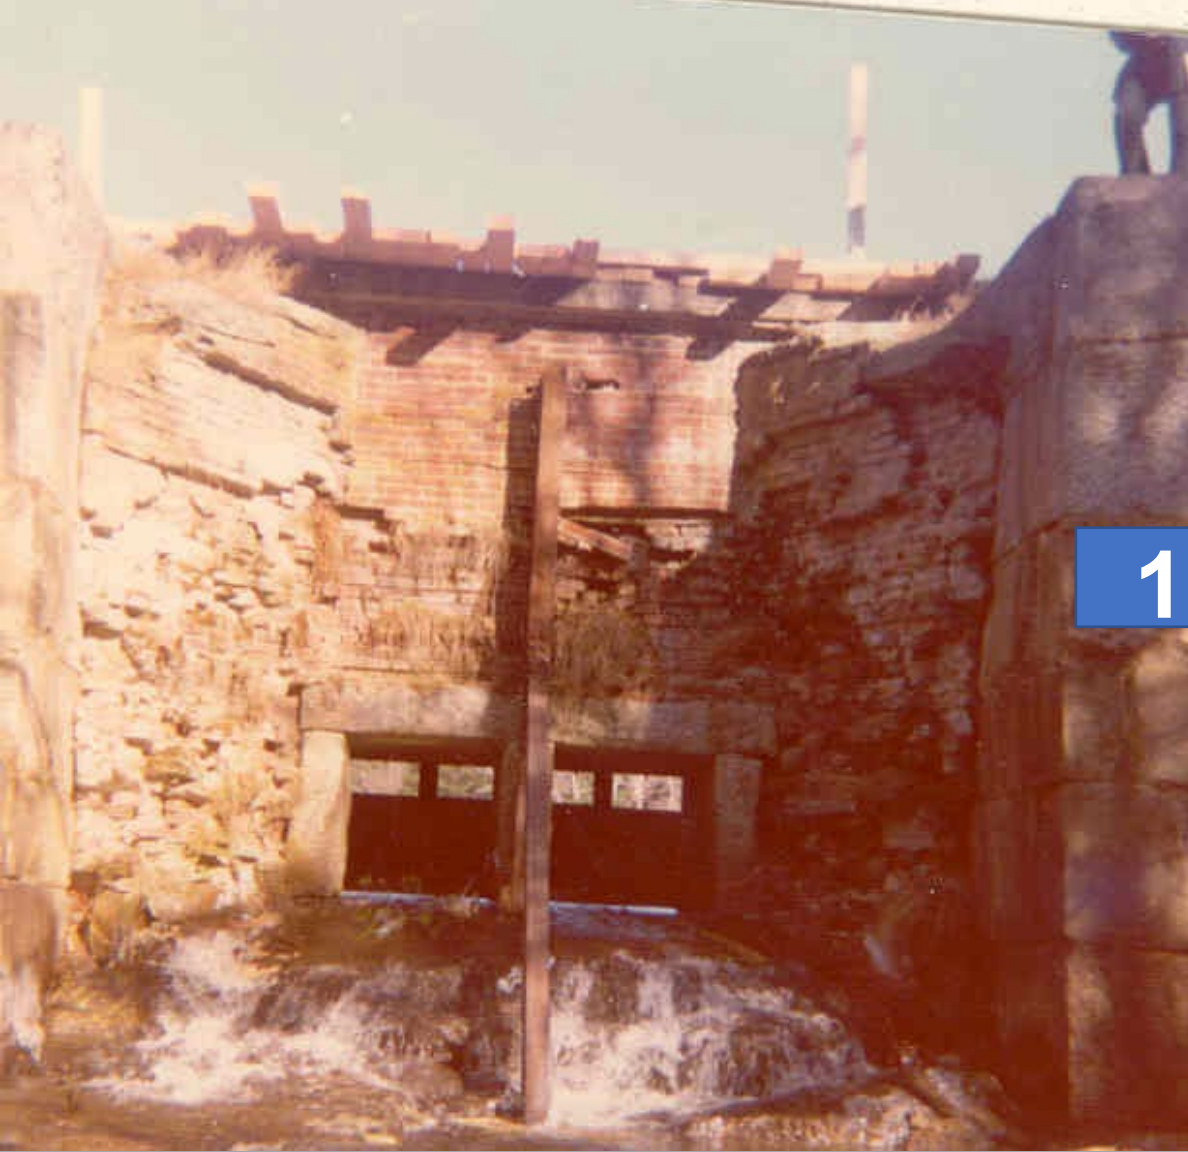
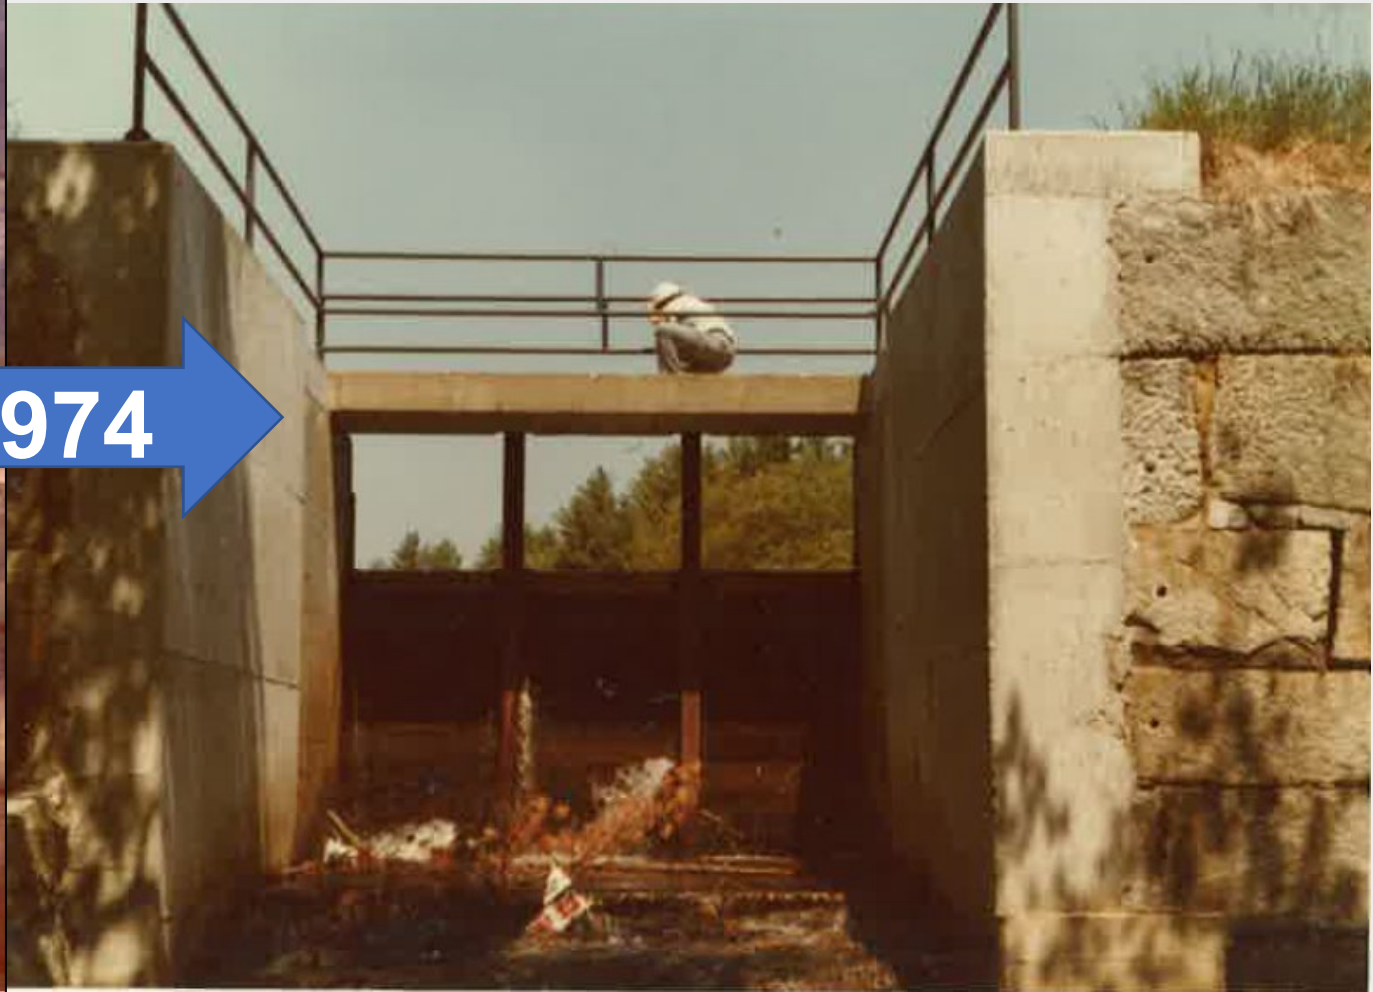
Original stoplog spillway section
built in 1956 (1974 photo)

Post-1974 reconstruction
(1978 photo)

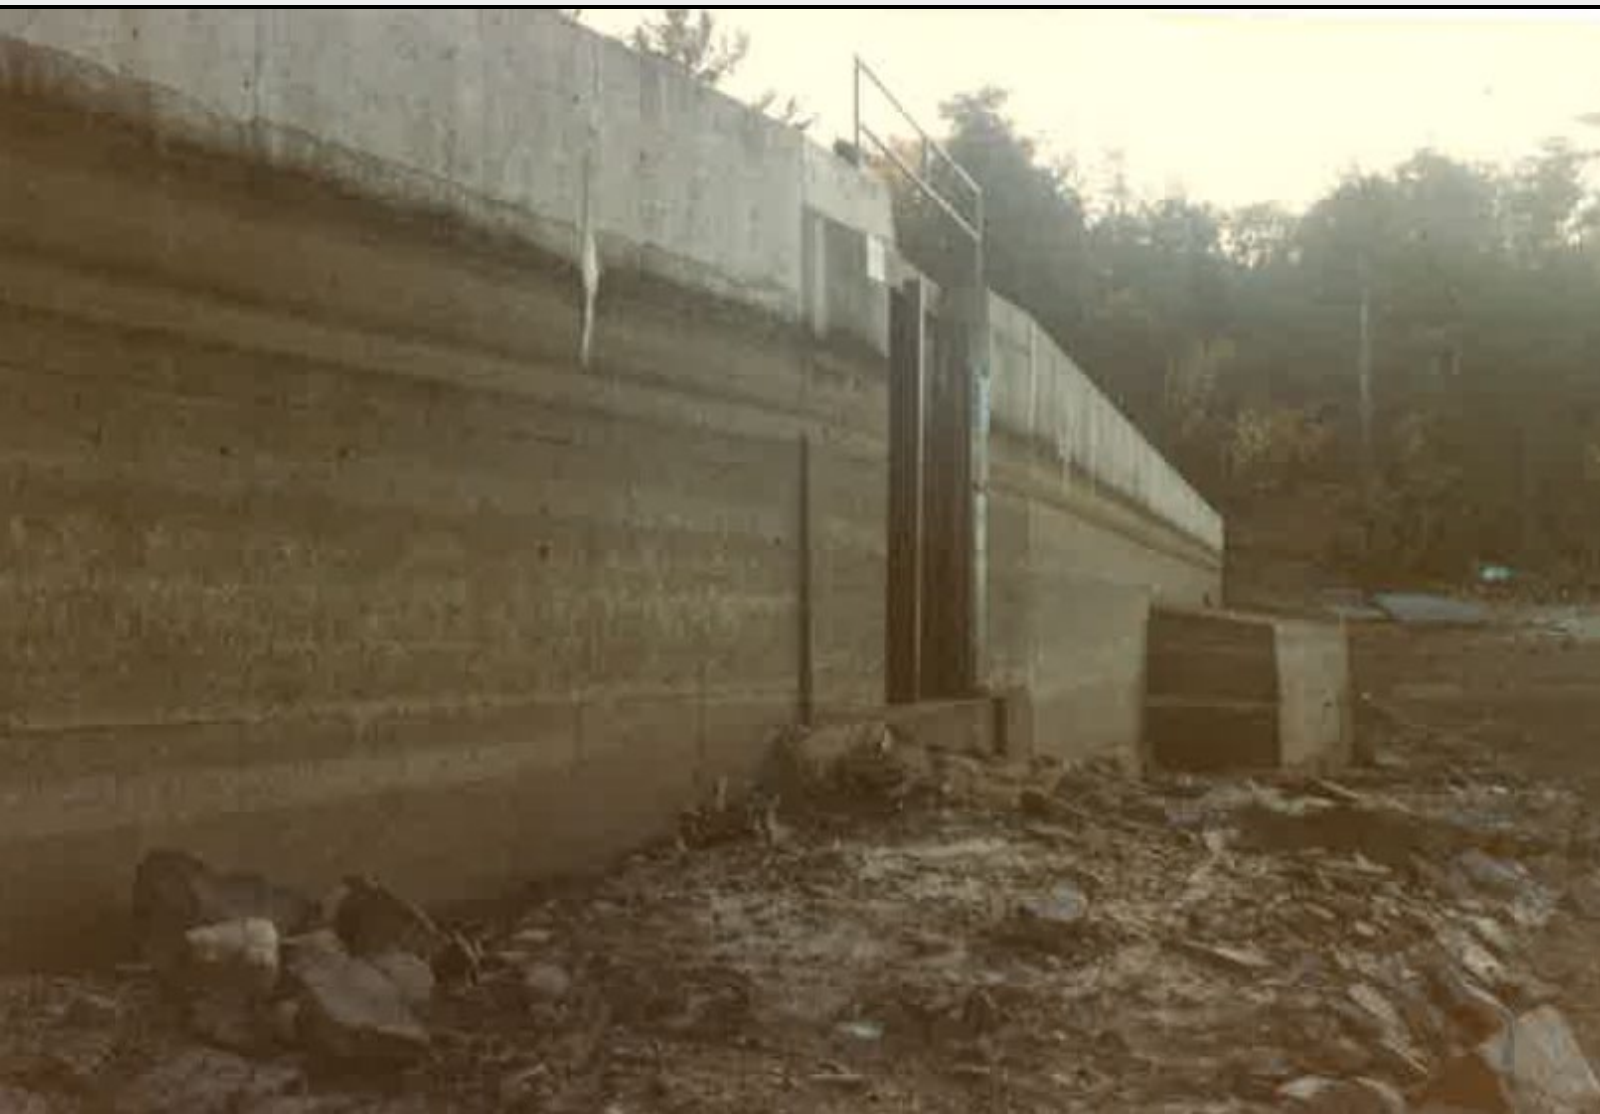
***"Substantial leakage" observed around the wooden gate and numerous large leaks were flowing from cracks in the sidewalls.

Water flowing from the base of the lowest rock berm at the toe of the dam.

Seepage observed along the bottom of the sidewalls.

Bulging and tilt was observed in the top part of the vertical dry masonry wall.

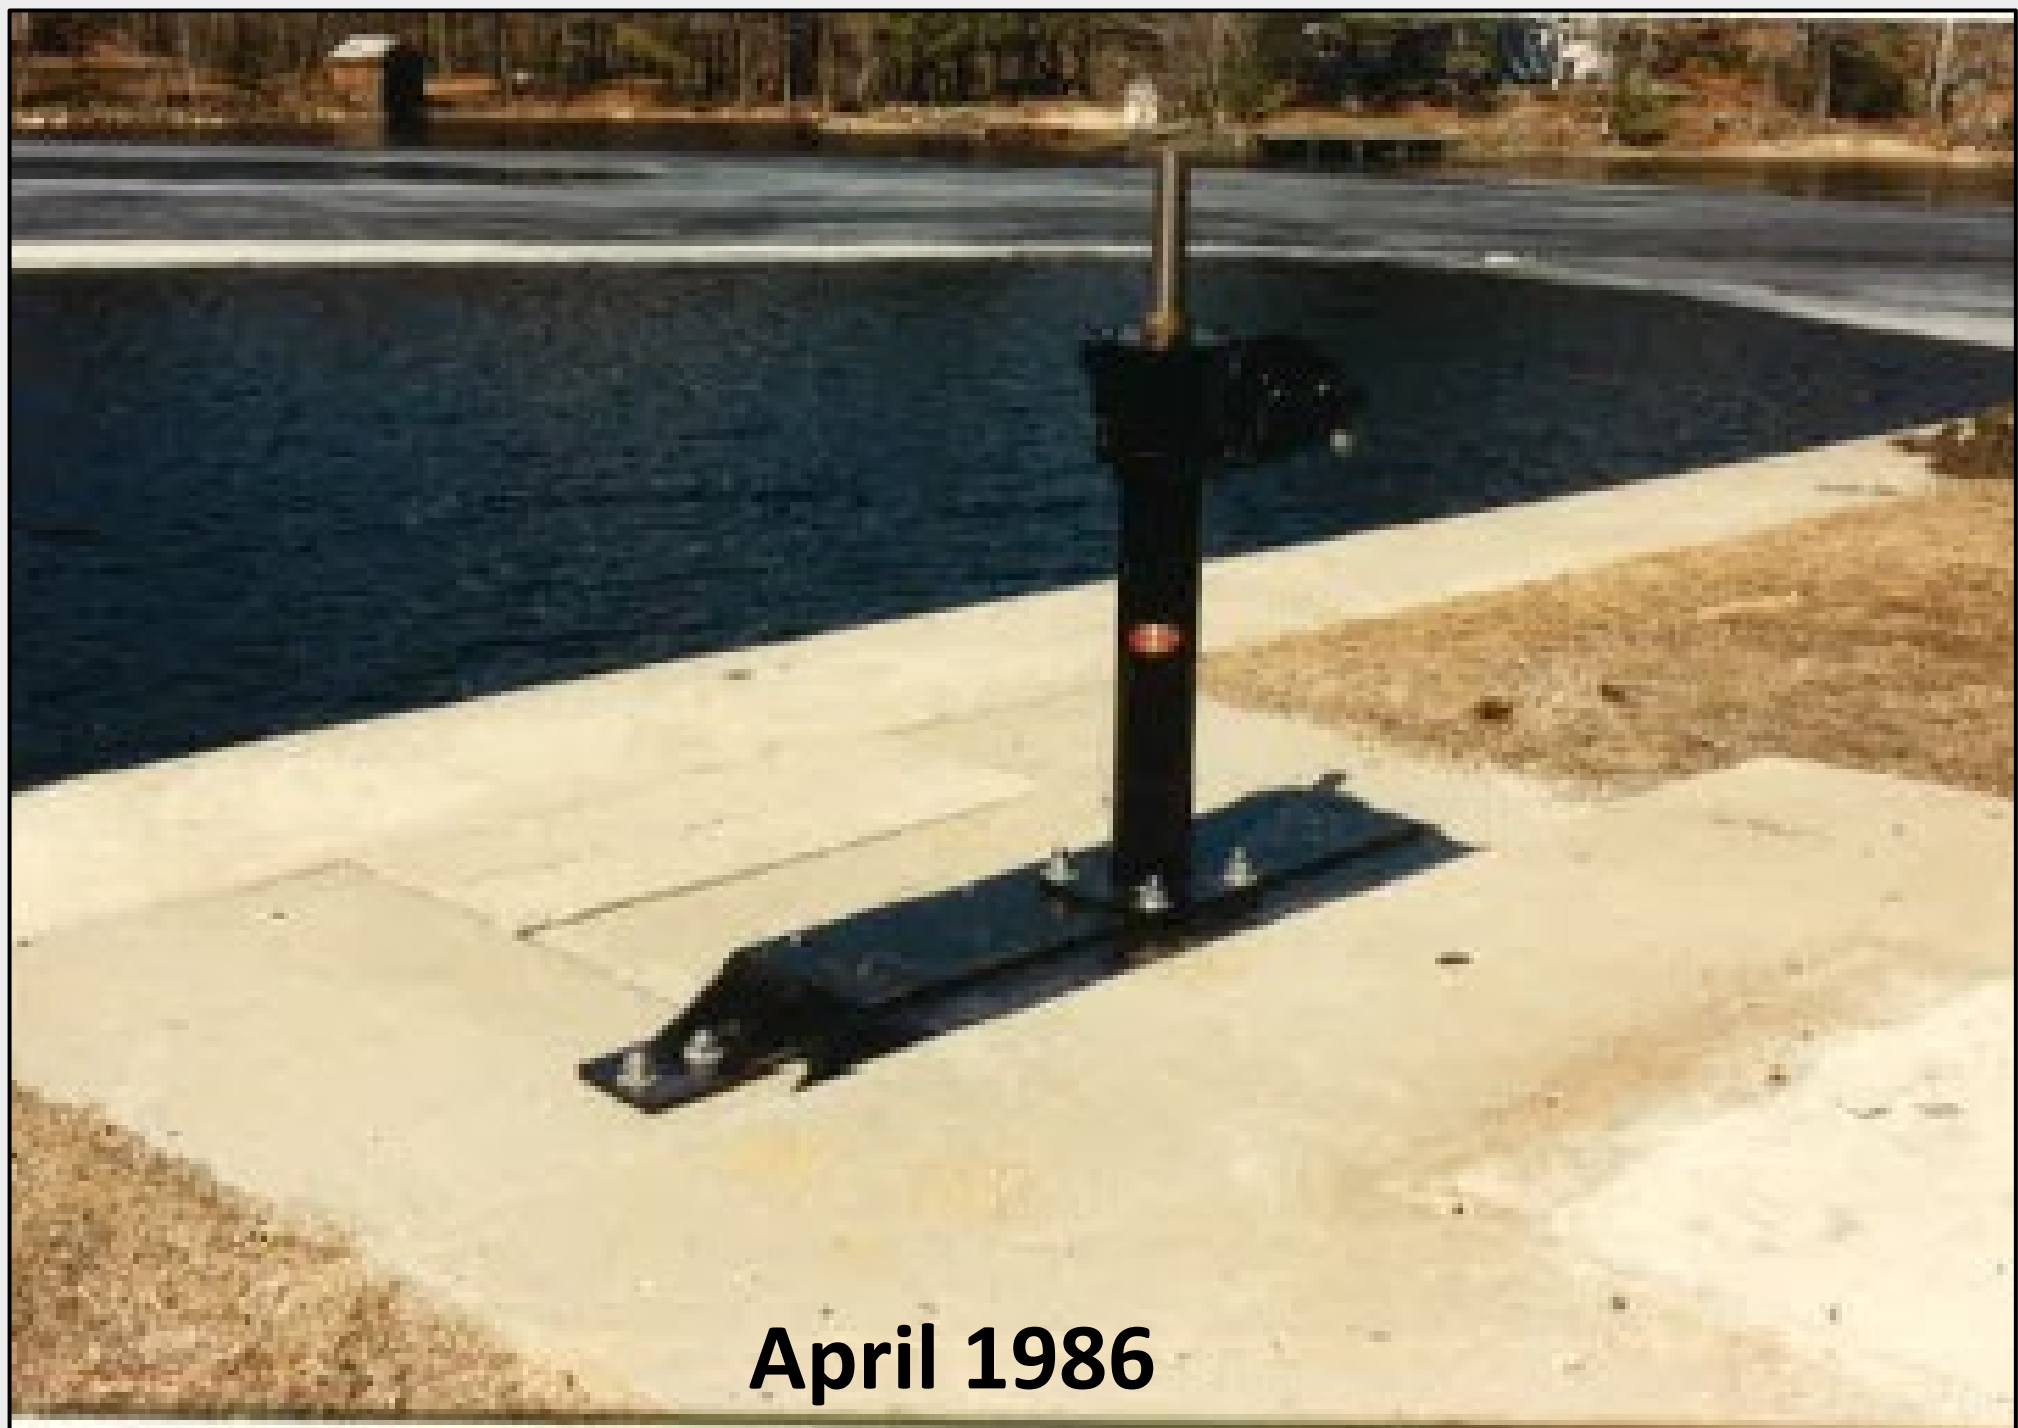
Gate Repair - Dec. 1985

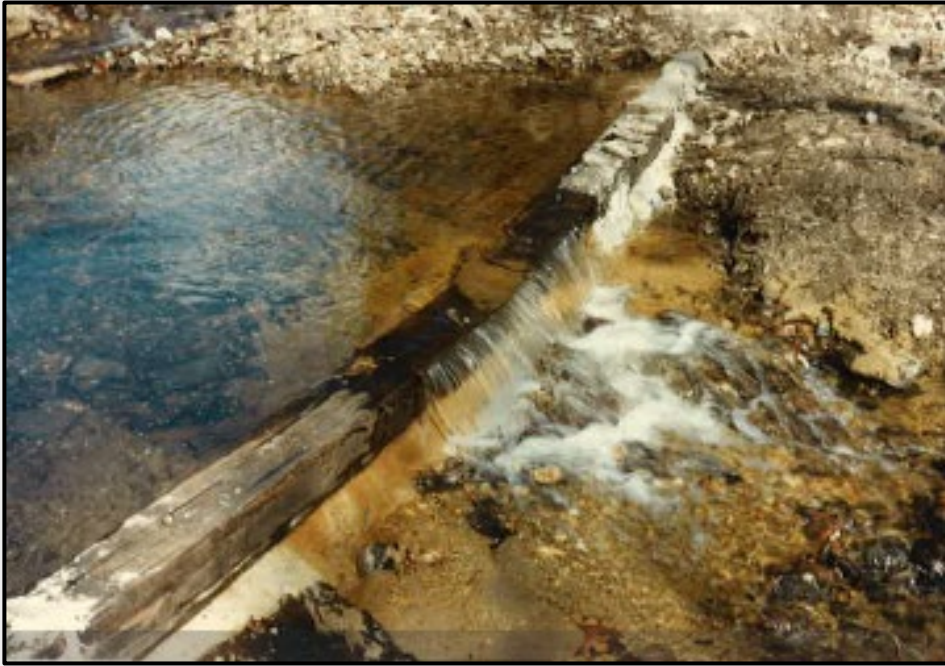
Wooden weir installed to monitor leakage from gate structure

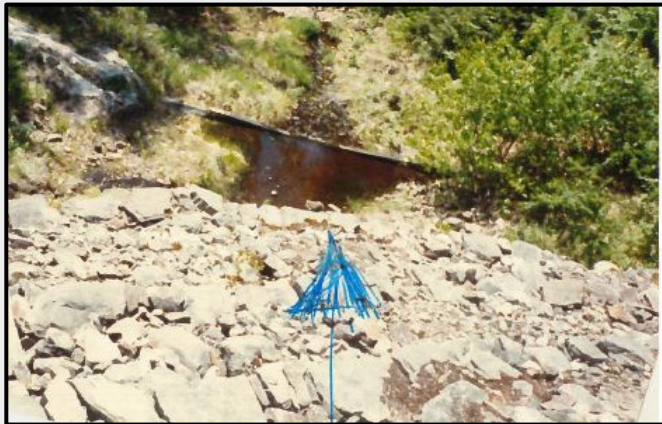
Subsurface exploration and installation of monitoring wells (wells also installed in 1997)

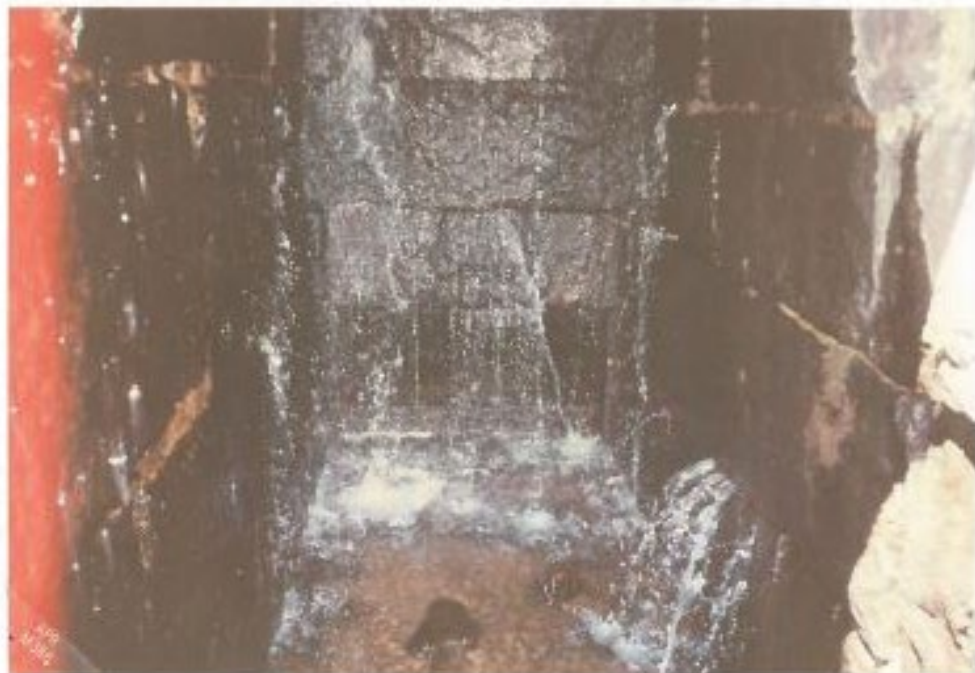
Gate Leakage

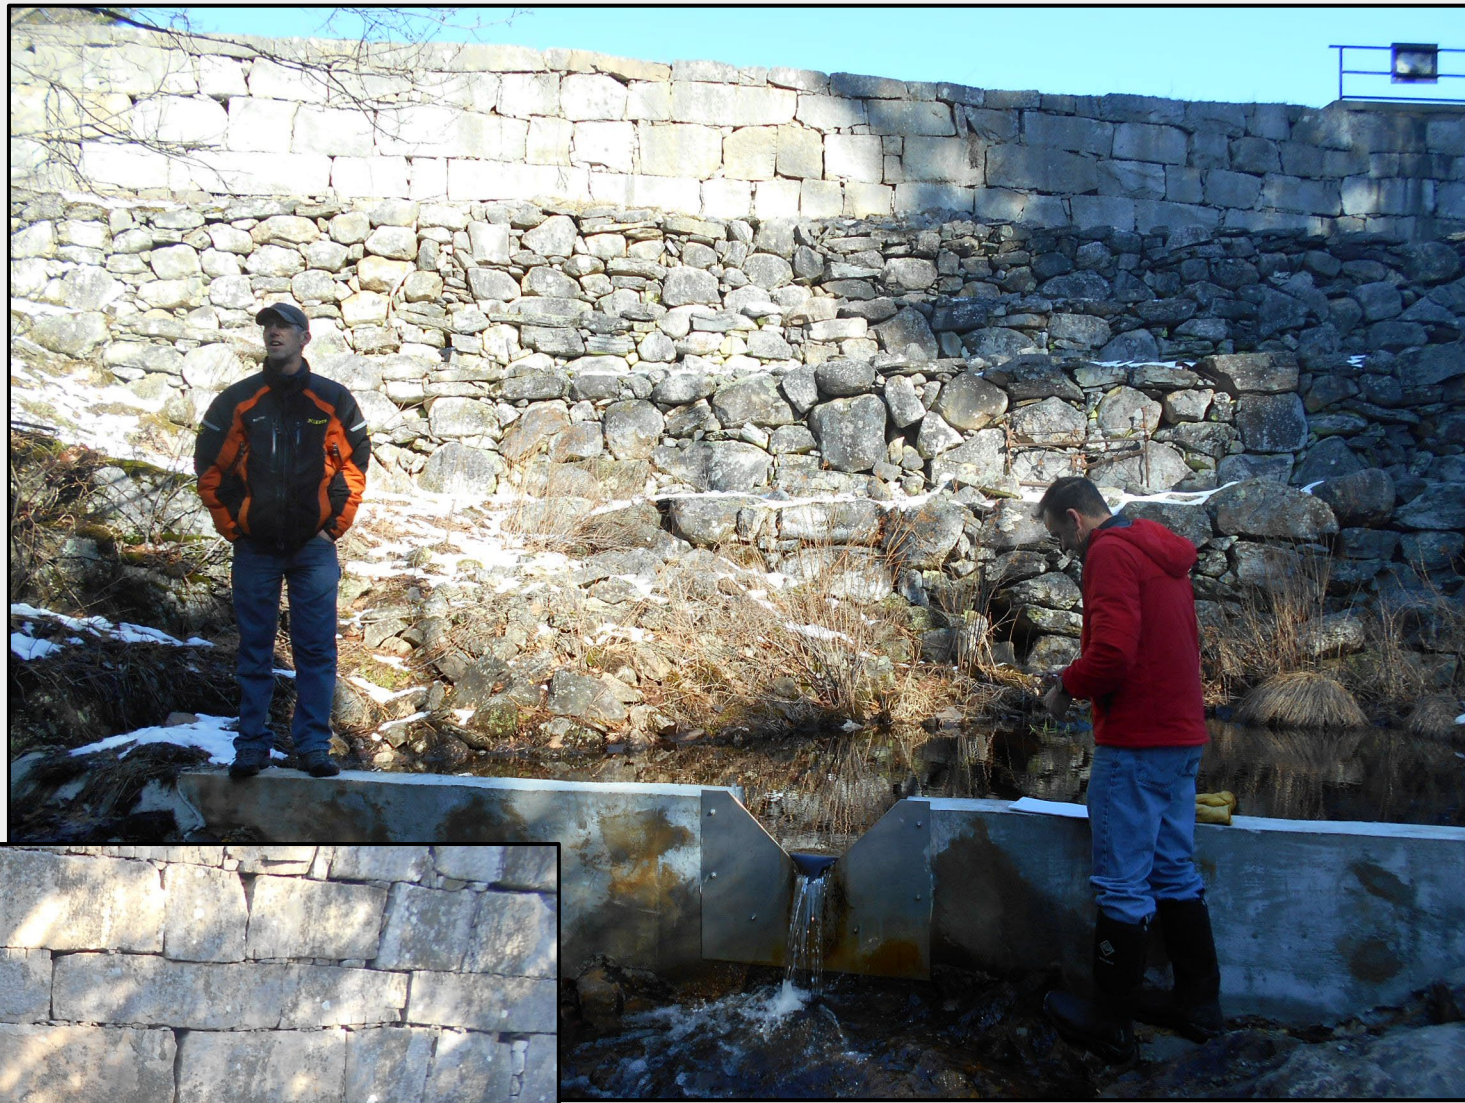
Sink Hole

Address sinkhole development at Dollof – **ongoing**

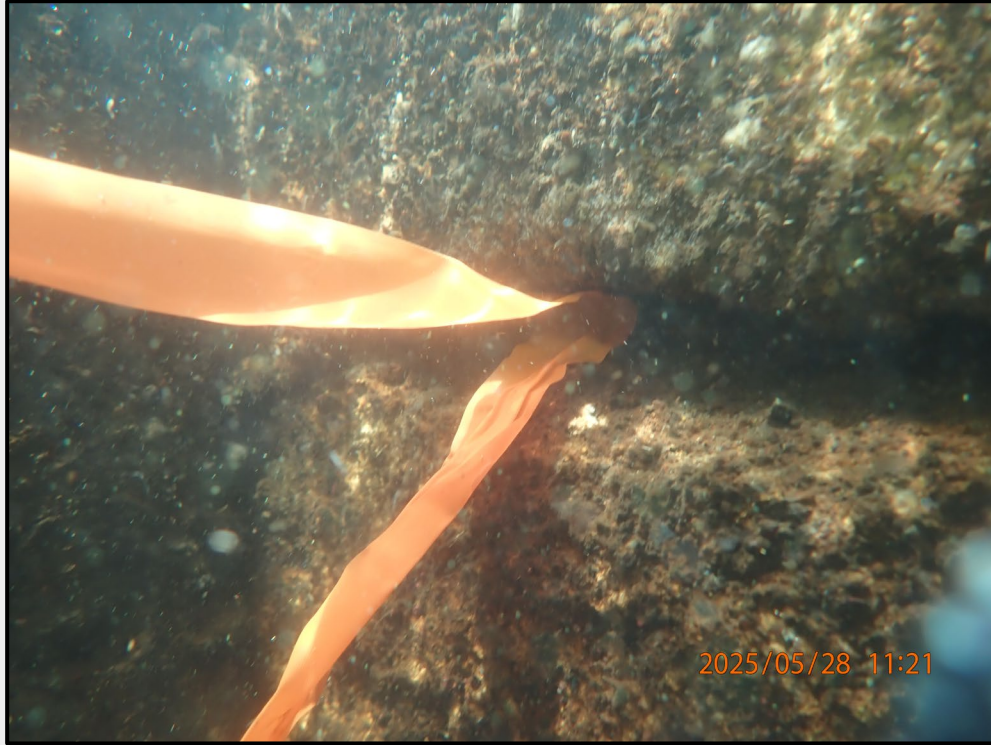
“Multiple locations of seepage through a horizontal crack, spalling, isolated poor consolidation, and open joints in the vertical shaft”
