Pawtuckaway Lake Dams

Pawtuckaway Lake Improvement Association

Corey Clark – Chief Engineer

New Hampshire Department of Environmental Services

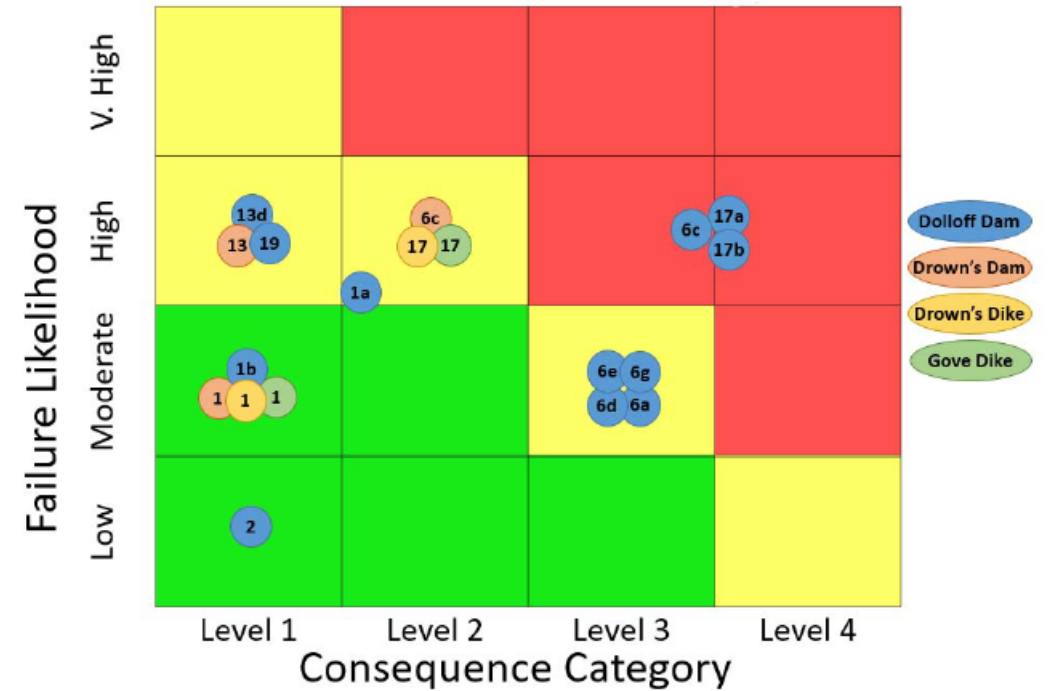
Figure 9 - PFMA Binning Chart

- PFM 1:** Erosion of Abutment(s) during Overtopping Flood Causing Uncontrolled Release and Loss of Access
 - PFM 1a involves erosion of the left abutment at Dolloff Dam.

- PFM 1b involves erosion of the right abutment at Dolloff Dam.
- PFM 2:** Failure of Spillway Bridge Causing Loss of Bridge and Access
- PFM 6:** Saturated or Partly-Saturated Earth Fill Destabilizes Downstream Masonry Wall Causing Uncontrolled Release

- PFMs 6c and 6d occur during an overtopping flood, which would saturate the embankment fill leading to destabilization.
 - PFMs 6a, 6e, and 6g occur during a non-overtopping flood, which would elevate the phreatic surface in the fill between the masonry walls leading to destabilization.

- PFM 13:** Vandals Remove Stoplogs/Open Gate Causing Uncontrolled Release
- PFM 17:** During Overtopping Flood, Saturated Embankment Fill and Erosion of Buttress at Toe of Dam Destabilizes Downstream Masonry Wall Leading to Uncontrolled Release
