Pawtuckaway Lake Storm Water Management Assessment

MAY 2007

**New Hampshire Department of
Environmental Services**
29 Hazen Drive
Concord, NH 03302-0095

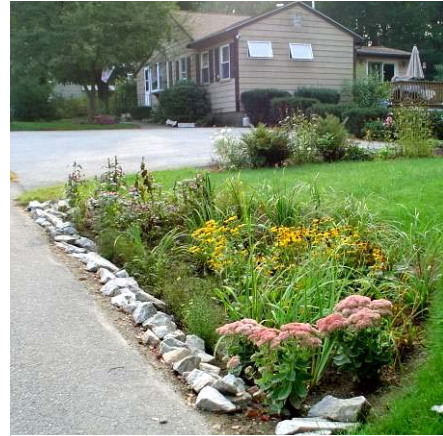
A rain garden installed on a residential property.

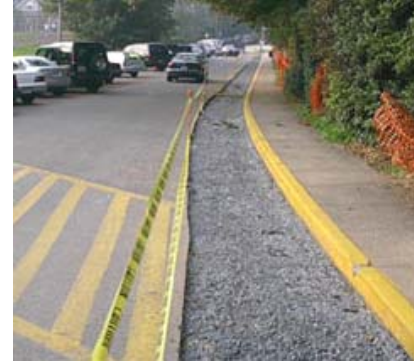
A stone-filled infiltration trench constructed to intercept runoff from the adjacent road.

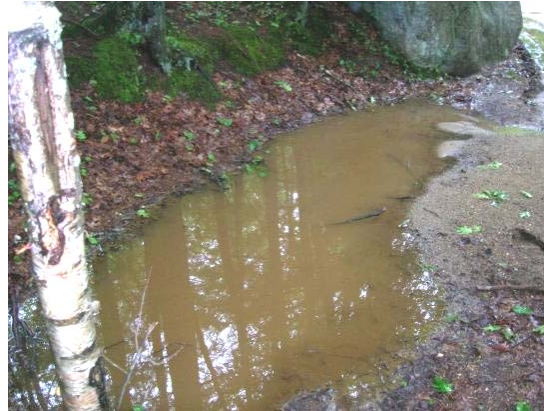
Photo # 1-1

Storm water run-off from the area of #99 Lakeview Drive collects in small topographical depressions in the gutter line of the unpaved road (Photo 1-1). The accumulated storm water drains into a drop inlet structure located adjacent to Lakeview Drive. Accumulated leaf litter was observed on the grate and sediment was observed in the sump of the drop inlet structure (Photo 1-2). The drop inlet structure apparently discharges via two 4-inch diameter PVC culverts directly into Neals Cove (Photo 1-3).

A bioretention cell is recommended at this drop inlet structure to reduce pollutant discharges directly to Neals Cove. The retrofit may include:

- A trenched ring around the device that would be lined with stone overlain by a bioretention soil mixture with plantings. The cell would provide filtration and promote infiltration.
- In addition, improvements may include cleaning and increasing the structure's sump to provide additional sediment capture. Bioretention cells are described in Section 2.0.

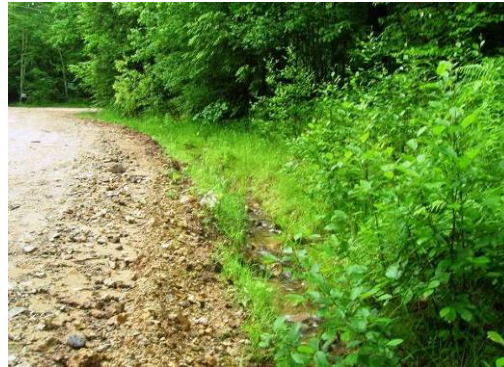
Photo # 2-1

Storm water runoff from Barderry Lane in the area of Fernalds Creek drains via a road side ditch (Photo 2-1) toward the Creek. The ditch drains from Barderry Lane into the area adjacent to Fernalds Creek, transporting sediment from the unpaved road surface to the Creek (Photo 2-2). Accumulated sediment was observed in this area adjacent to Fernalds Creek (Photo 2-3).

Structural bank stabilization is recommended along the west side of Barderry Lane. The wall would be constructed from stone-filled gabion baskets in combination with coir fiber rolls. Gabion basket walls provide cost effective bank stabilization while also providing stone media for storm water filtration.

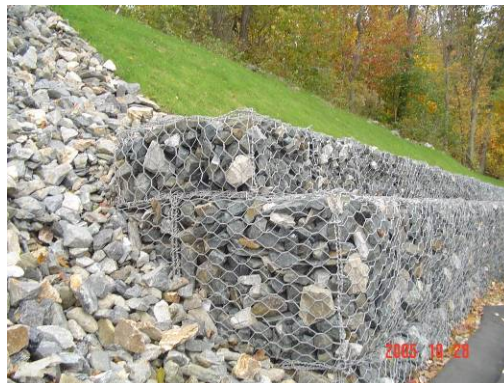
Example of gabion basket wall

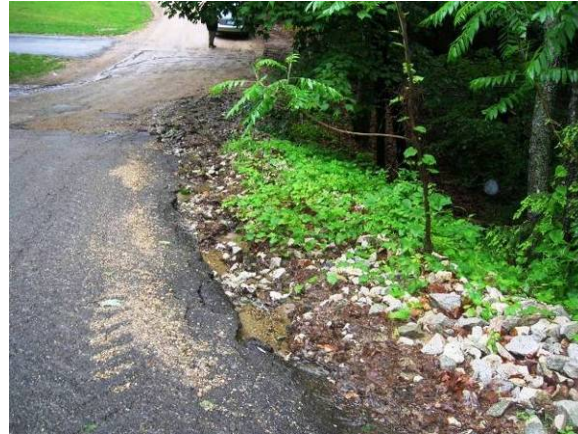
Photo # 3-1

Storm water runoff from paved portions of Lakeview Drive drain via overland flow onto the unpaved Lookout Point (Photo #3-1). These flows concentrate along the unpaved eastern side of Lakeview Drive in an undefined road ditch. The undefined ditch apparently drains along a paved driveway toward Mountain Brook Cove (Photo #3-2). Accumulated sediment was observed at the down gradient end of the paved driveway, adjacent to Mountain Brook Cove (Photo #3-3).

A stone drainage channel is recommended to be installed along the eastern side of Lakeview Drive/Lookout Point and continued along the paved driveway shown in Photo3-2. The drainage channel would ultimately discharge to Mountain Brook Cove and consist of:

- A deep rock-lined trench that would provide a well defined storm water conveyance to provide filtration and promote infiltration.
- The trench would function to capture storm water runoff from the paved portions of Lakeview Drive and either infiltrate these flows or convey flows in a controlled, non-erosive manner to Mountain Brook Cove.

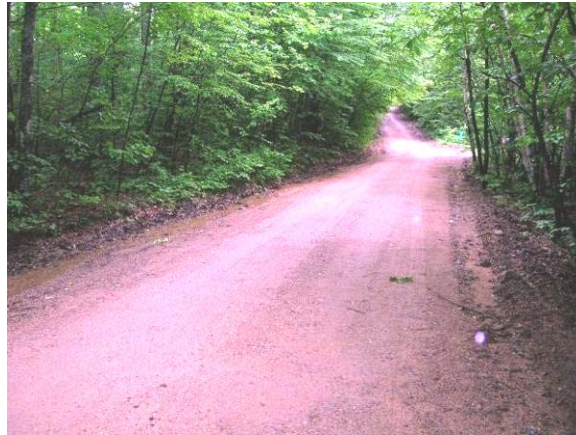
Photo # 4-1

Jasper Trail is an unpaved road as shown in Photo #4-1. Storm water runoff from Jasper Trail drains into undefined ditches along both sides of the Trail. In addition, a small unnamed tributary drains from Sax Hill toward Jasper Trail. The stream drains across the road via a 12" diameter culvert. The culvert apparently has caused flooding that has resulted in Jasper Trail being eroded (i.e., washed-out). The culvert inlet (Photo #4-2) is not protected and sediment from the unpaved road run-off has accumulated at the culvert inlet, thereby reducing the capacity of the culvert. In addition, accumulated sediment was observed immediately down gradient of the culvert outlet (Photo #4-3). The stream discharges from the culvert and drains south along Jasper Trail and then east toward Pawtuckaway Lake.

Recommended storm water improvements in the area of the Jasper Trail culvert include:

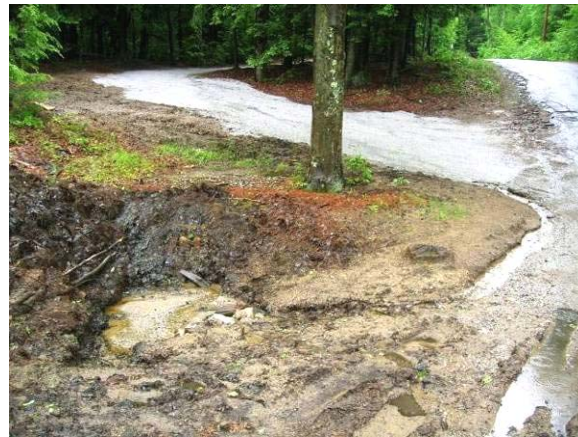
Photo # 5-1

Storm water runoff from the paved portions of Lakeview Drive in the area of #105 Lakeview Drive drain via a 12" diameter culvert located on the north side of the road (Photo #5-1). The area adjacent to the culvert inlet was not stabilized and rills were observed in adjacent side slopes (Photo #5-2). The culvert apparently drains into one of two catch basin structures that captures storm water runoff from the paved driveway of #105 Lakeview Drive (Photo #5-3). These catch basin structures appear to discharge to Neals Cove via a culvert through private property.

Recommended storm water controls in the area of #105 Lakeview Drive include retrofit LID technologies to improve storm water quality discharging to Neals Cove. Recommended improvements include:

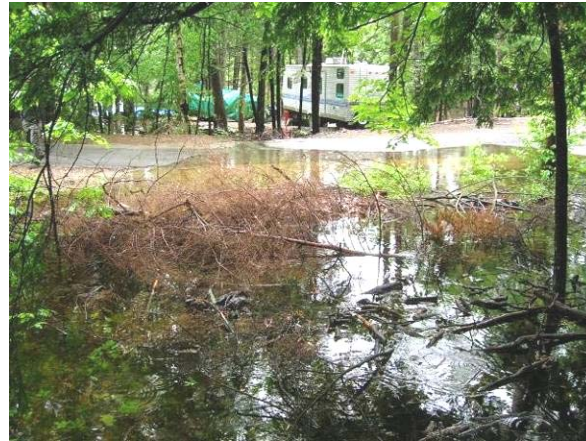
Photo # 6-1

Storm water runoff in the area of #47 Lakeview Drive apparently accumulates and can cause flooding of Lakeview Drive (Photo #6-1). The accumulated storm water discharges across Lakeview Drive. These flows discharge from the pavement onto unstabilized side slopes before draining overland toward Mountain Brook Cove. Evidence of erosion was observed in the unstabilized areas down gradient of the pavement (Photo #6-2). These flows then drain overland to a series of topographical depressions and eventually drain into Mountain Brook Cove (Photo #6-3).

Storm water runoff in the area of #46 Lakeview should be controlled to reduce flooding and erosion caused by flow over unstabilized surfaces within close proximity to the lake. Recommended controls and improvements include:

- Installing a conveyance such as a culvert across Lakeview Drive to drain accumulated storm water.
- Clean the flooding area of accumulated tree/yard debris that has apparently been dumped in the area and is a potential source of pollutants (i.e., nutrients).
- Installing a bioretention cell along the west side of Lakeview Drive in the area of flooding to provide storm water runoff storage and promote infiltration.
- Additional recommended improvements include installation of an energy dissipation device and level spreader at the proposed culvert outlet to reduce flow velocities and promote non-erosive flows to drain overland through the forested area before discharging into Mountain Brook Cove.

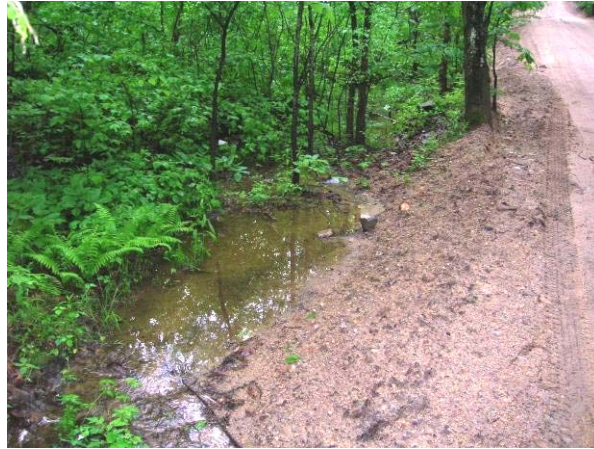
Photo # 7-1

Barderry Lane is an unpaved road that crosses a wetland complex that drains toward Gove Cove. The wetland along the east side of Barderry Lane drains west via several culverts. However, grading activities associated with unpaved road maintenance have apparently caused sediment to accumulate and block the inlets of at least one culvert (Photo #7-1). Flooding occurs in the area up gradient of the blocked culvert.

- Maintaining this area of Barderry Lane so that sediment is not transported to adjacent storm water controls (e.g., ditches, culverts).
- Cleaning the accumulated sediment that has clogged the culverts along this portion of road.
- Installing culvert headwalls to define the locations of culverts and provide stabilization to the road in these areas.
- Installing a well-defined ditch along the approximate 500 linear feet of Barderry Lane.
- Stabilizing ditches with rock or installing a deep rock-lined trench, to define the road boundary as well as treat and infiltrate storm water runoff. The trench would either infiltrate storm water runoff or convey these flows to one of the exiting culverts that drain west toward Gove Cove.

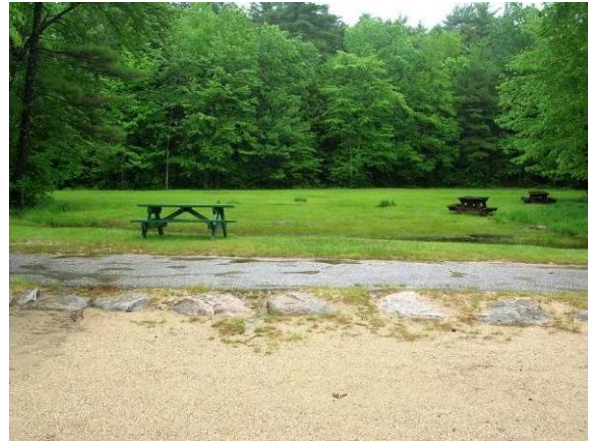
Photo # 8-1

Pawtuckaway Lake State Park is located along the west shore of the Lake, to the north of Neals Cove. There is a grassed picnic area located to the south of the main beach of the Park (Photo #8-1). Storm water runoff from this grassed area either infiltrates or drains via overland flow toward the Lake. Two catch basin structures capture the runoff and apparently discharge these flows to the Lake. The catch basin structures appear to not properly drain and flooding was observed in the area of both structures (Photo #8-2).

- Install bioretention cell at each of the drop inlet structures located to the south of the grassed picnic area. The bioretention cells would provide storm water filtration and storage capacity while promoting infiltration.
- Install an energy dissipation and level spreader device at the paved spillway at the southeast corner of the secondary parking lot. The energy dissipation device will reduce flow velocities prior to discharging runoff in a non-erosive manner to the unstabilized channel.
- Stabilize the existing channel down gradient of the paved spillway located in the southeast corner of the secondary parking area.

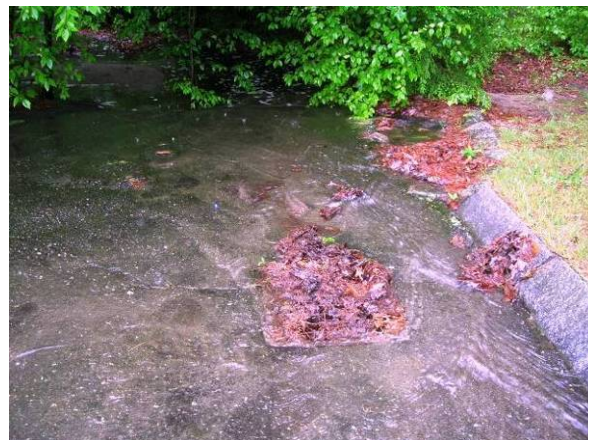
Photo # 8-3

The Park's secondary parking lot is located to the east of the main beach. Storm water runoff from the paved parking lot either drains into catch basins or discharges from the southeast corner of the parking lot via a paved spillway (Photo #8-3). The spillway discharges into an unstabilized channel and erosion was observed immediately down gradient of the spillway.
