Pawtuckaway Lake Dams

Pawtuckaway Lake Improvement Association

Corey Clark – Chief Engineer

New Hampshire Department of Environmental Services

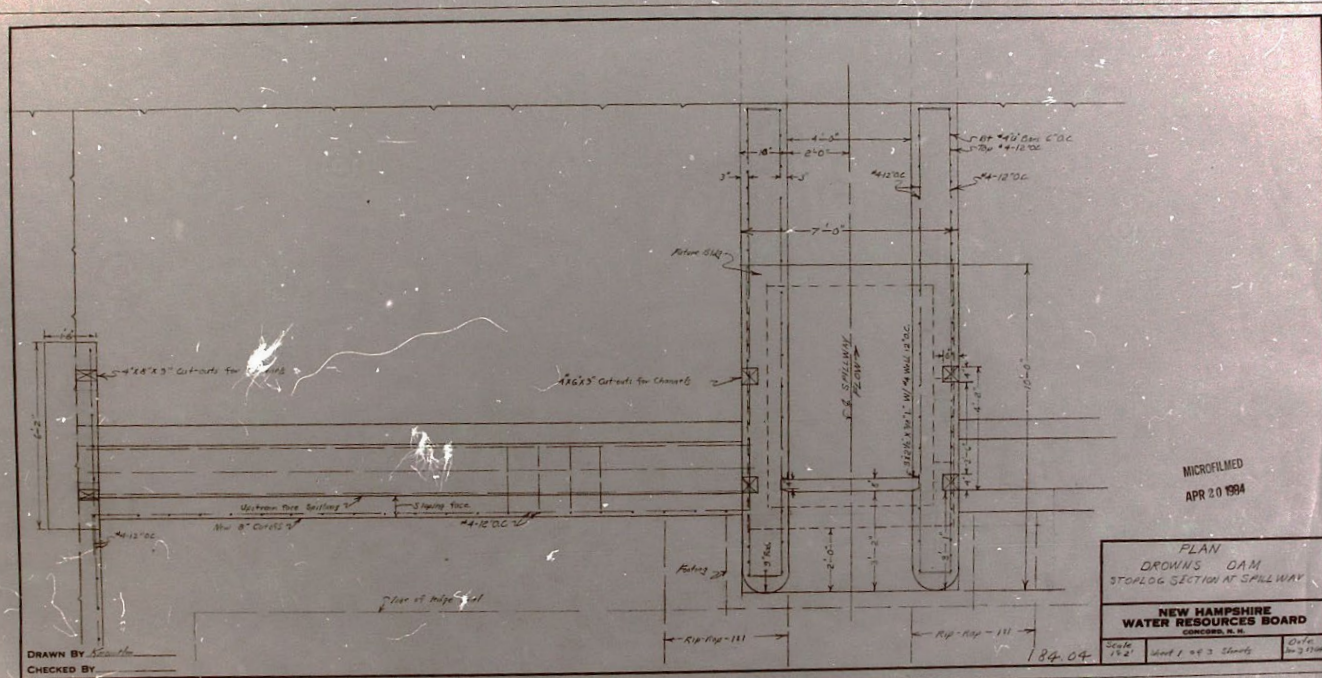
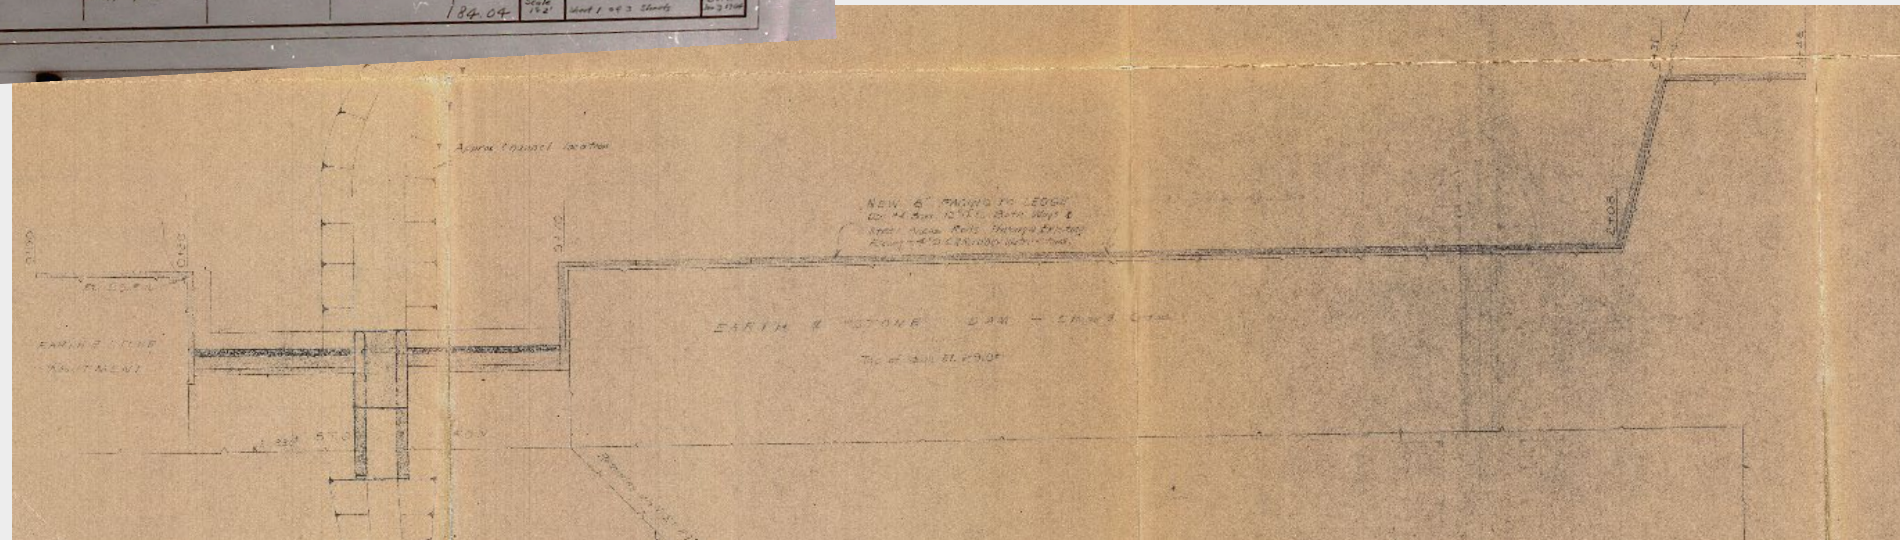
Drowns Dam (1963/1964)

**Seepage through the old penstock opening.

**Seepage through and/or under the dam.

1963 – new concrete facing

1964 – new concrete spillway
and stoplog bay

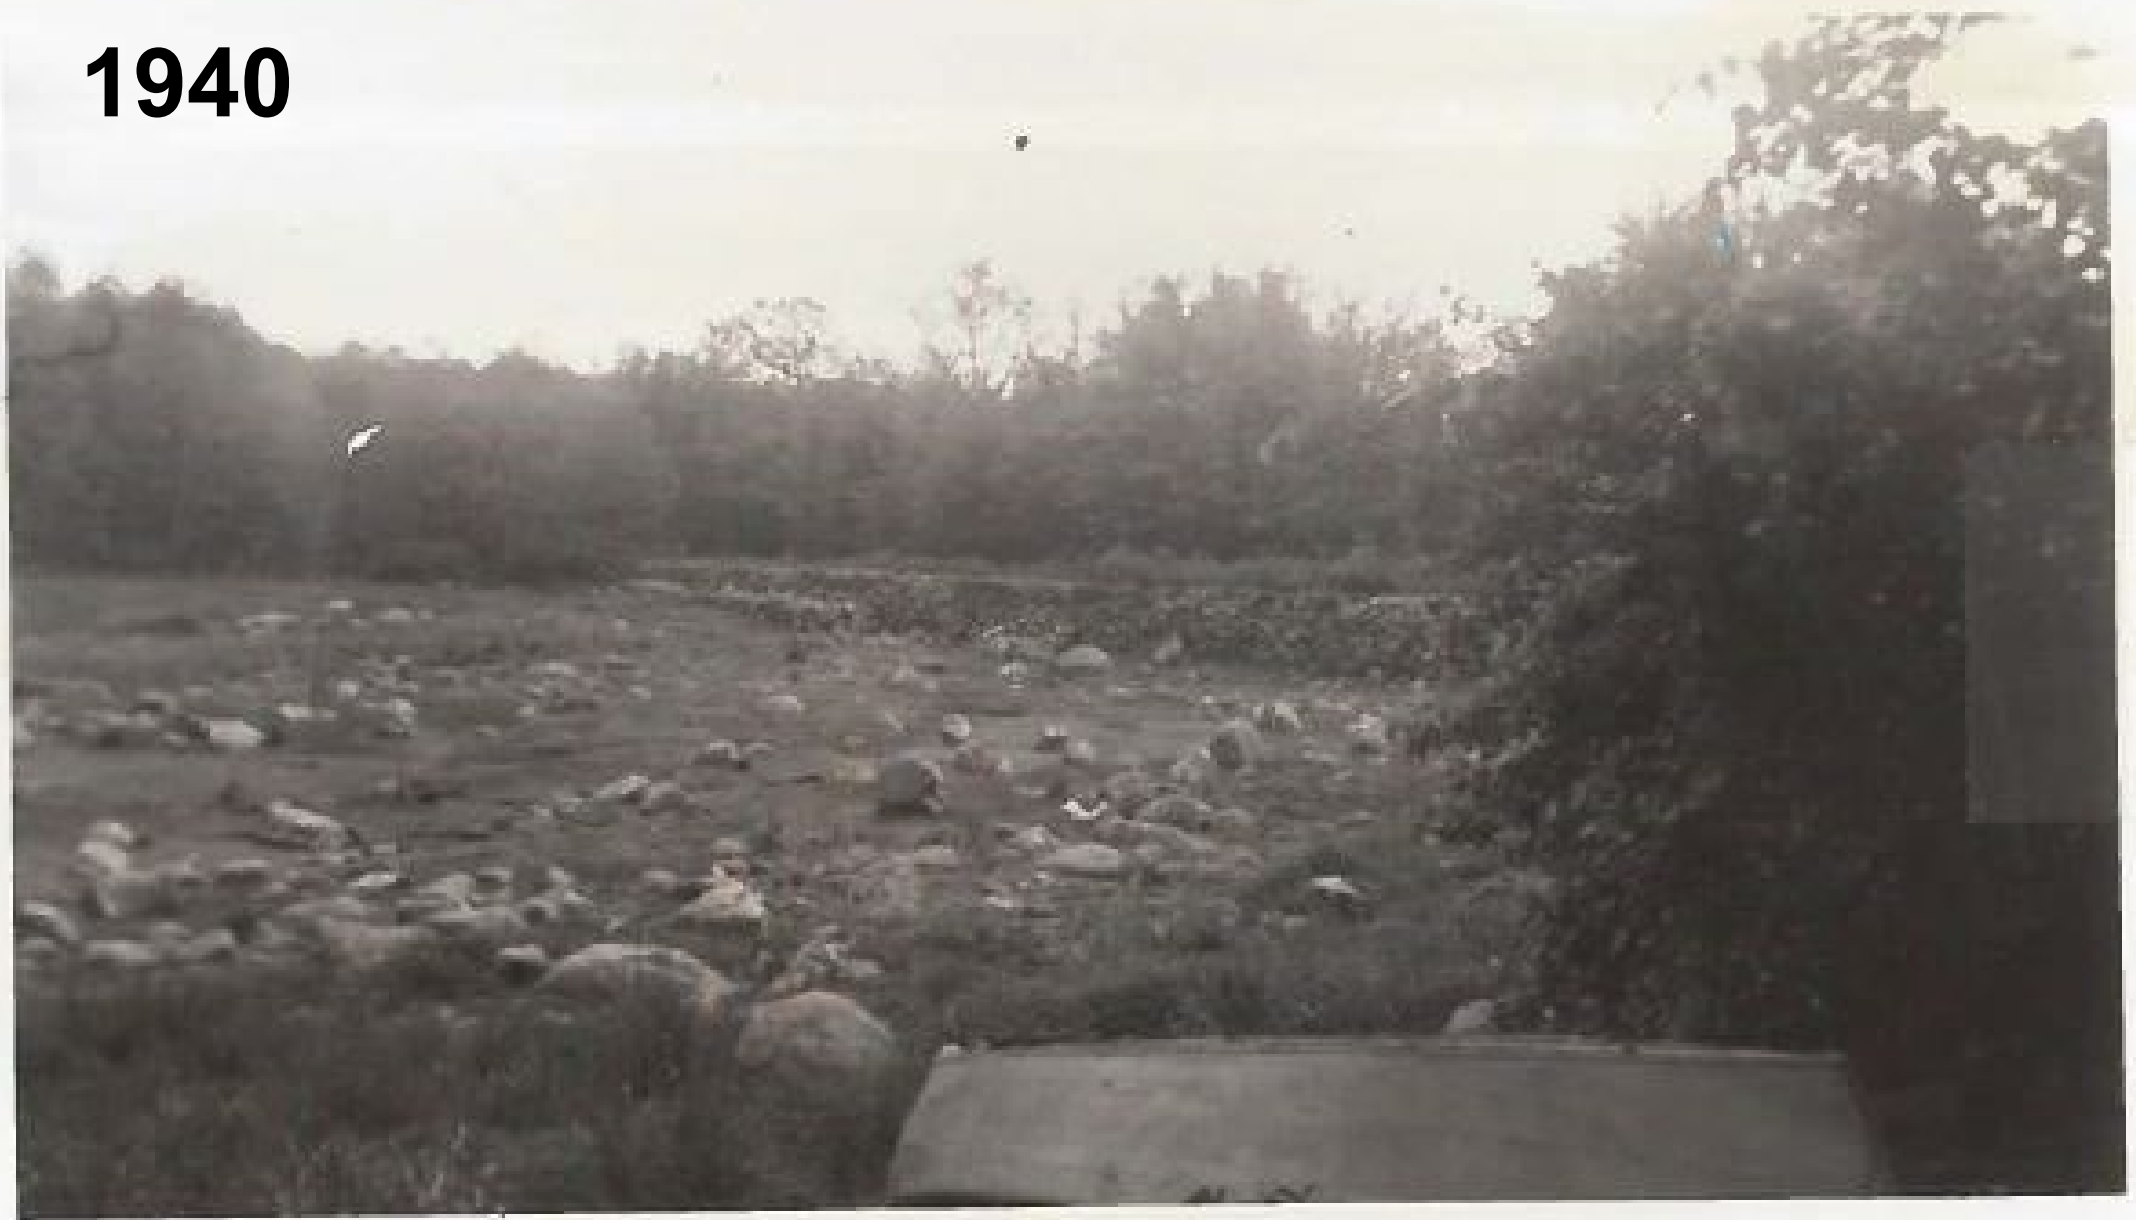
GOVE DIKE
NH 00135

"Numerous" large boulders were
dumped immediately downstream of
the dike on both sides.

Seepage and
standing water
visible
downstream of
right abutment.

Bulge in masonry wall
approximately 100 ft
from left abutment.

**Seepage estimated at
10 gpm about 15 ft
downstream of wall.

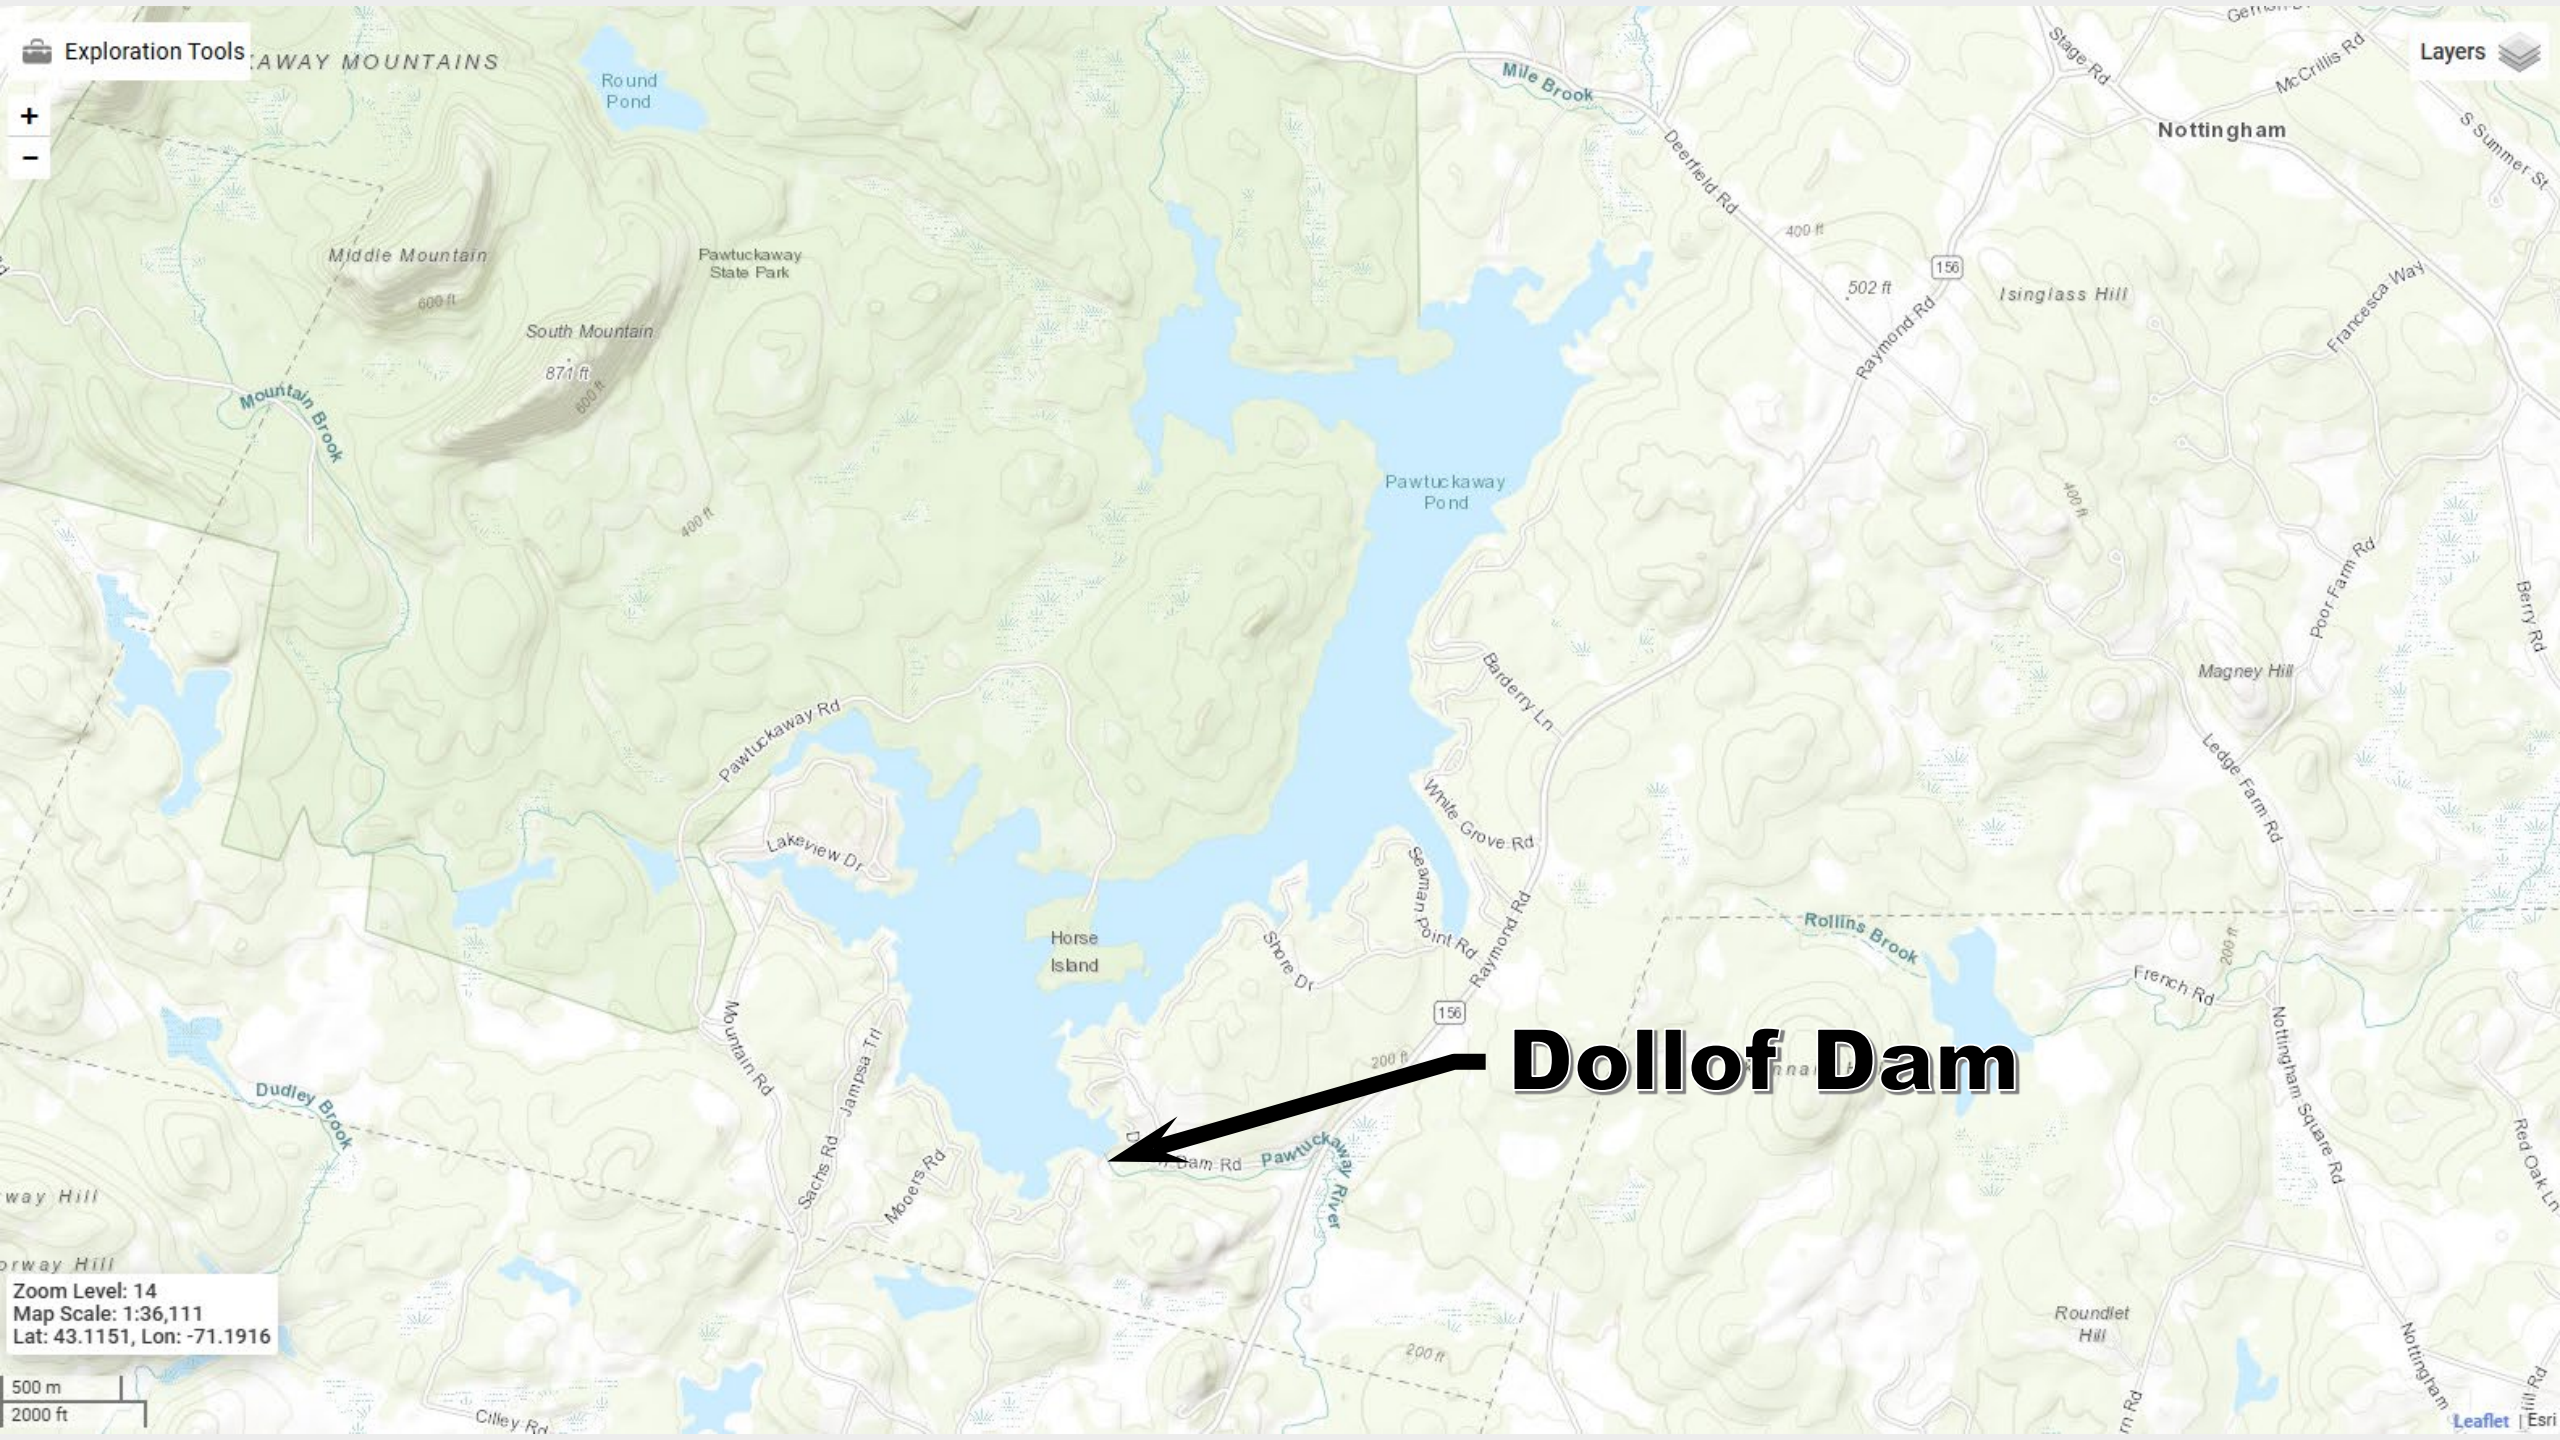
Cross Section
of
DOLLOF DAM (No 1)
Nottingham N.H.
Scale 10' to the inch.
Copied Nov. 1918 by J.H. Litchfield
from drawings in a report by
W.M. Oliver, C.E. to the Newmarket
Manufacturing Co. dated 1889.

Dollof Dam
26 feet tall
414 feet long

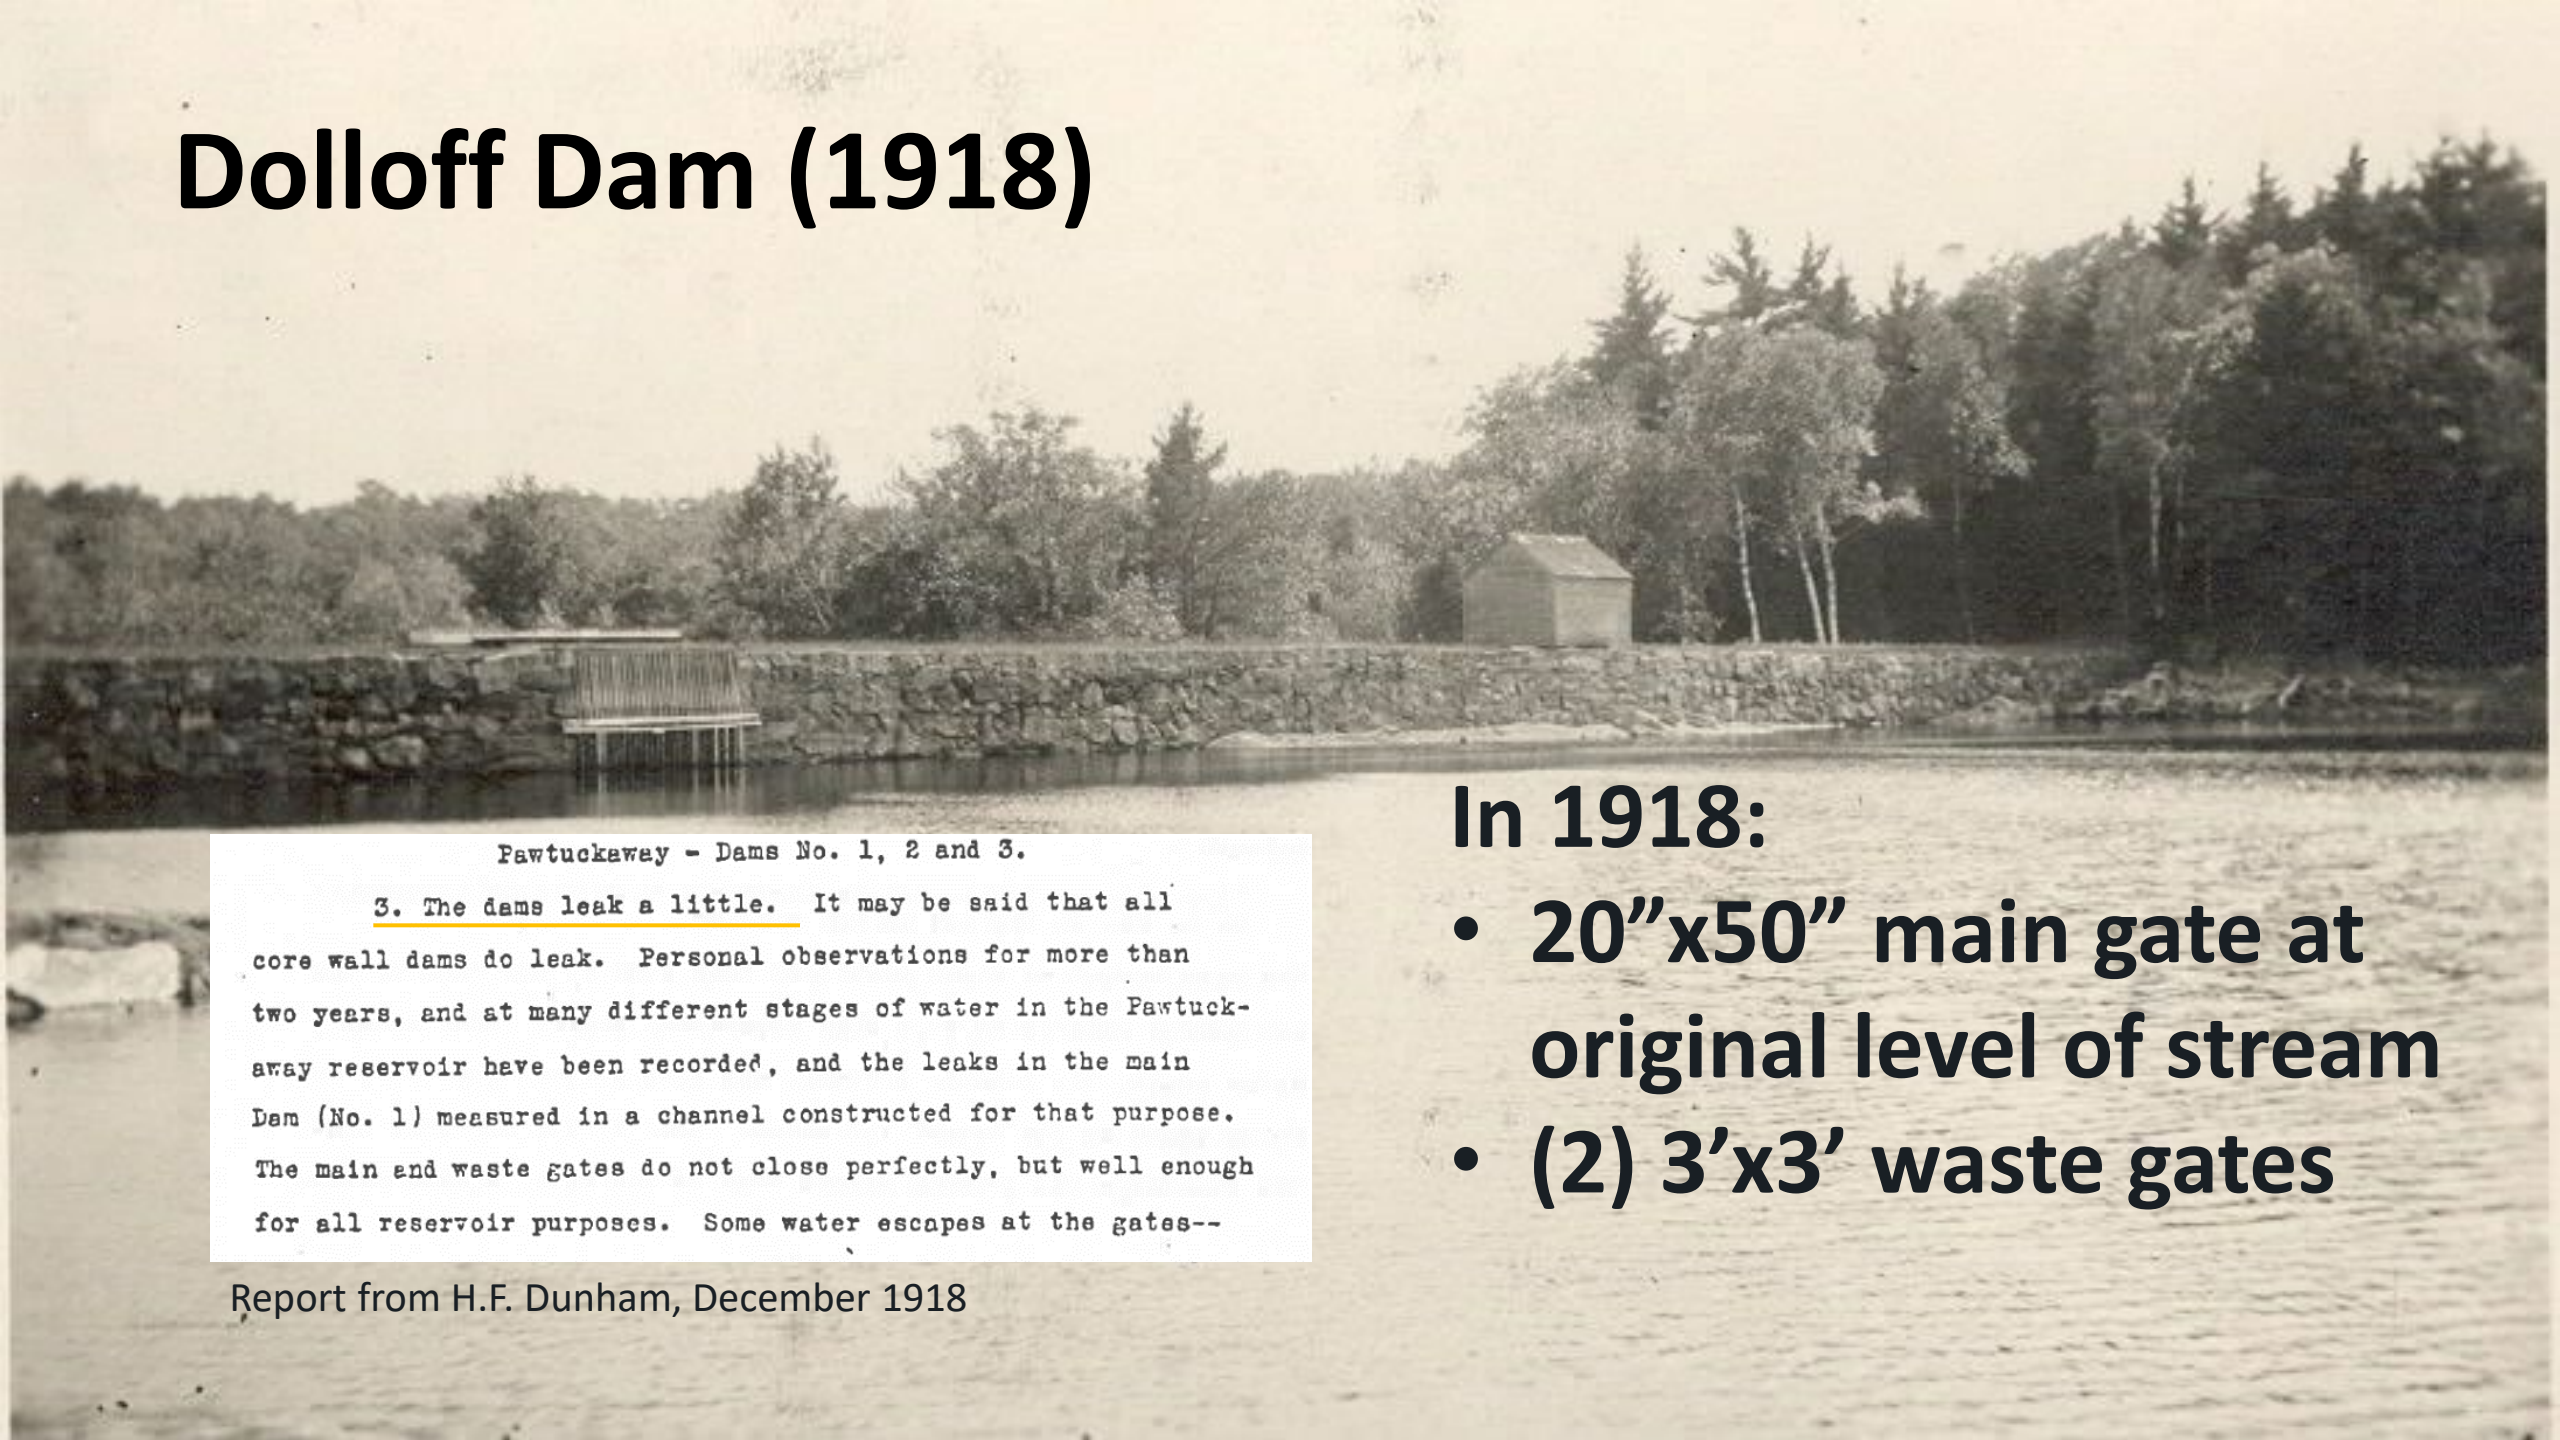
Pawtuckaway - Dams No. 1, 2 and 3.

3. The dams leak a little. It may be said that all core wall dams do leak. Personal observations for more than two years, and at many different stages of water in the Pawtuckaway reservoir have been recorded, and the leaks in the main Dam (No. 1) measured in a channel constructed for that purpose. The main and waste gates do not close perfectly, but well enough for all reservoir purposes. Some water escapes at the gates--

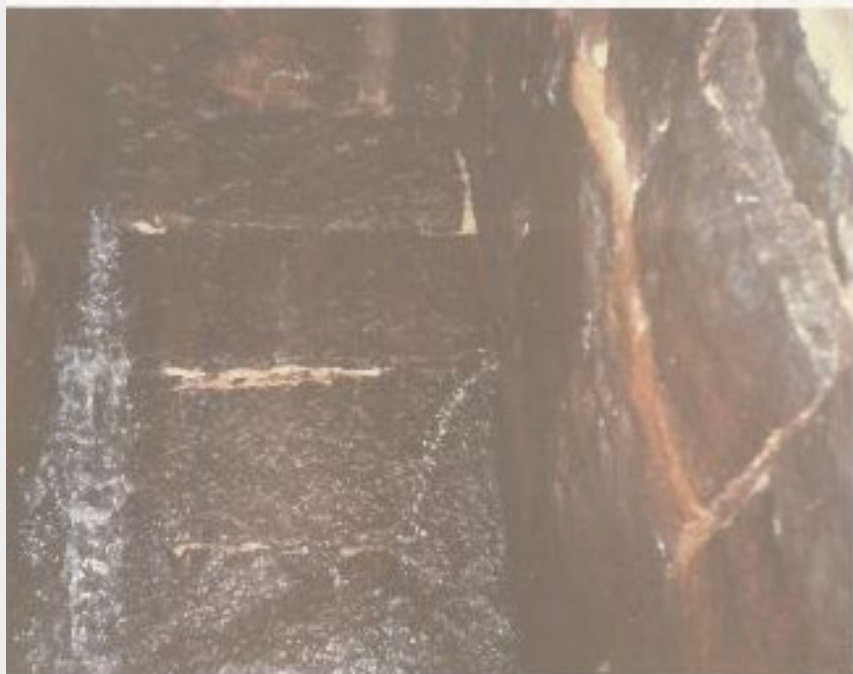
Seepage in
gate house shaft

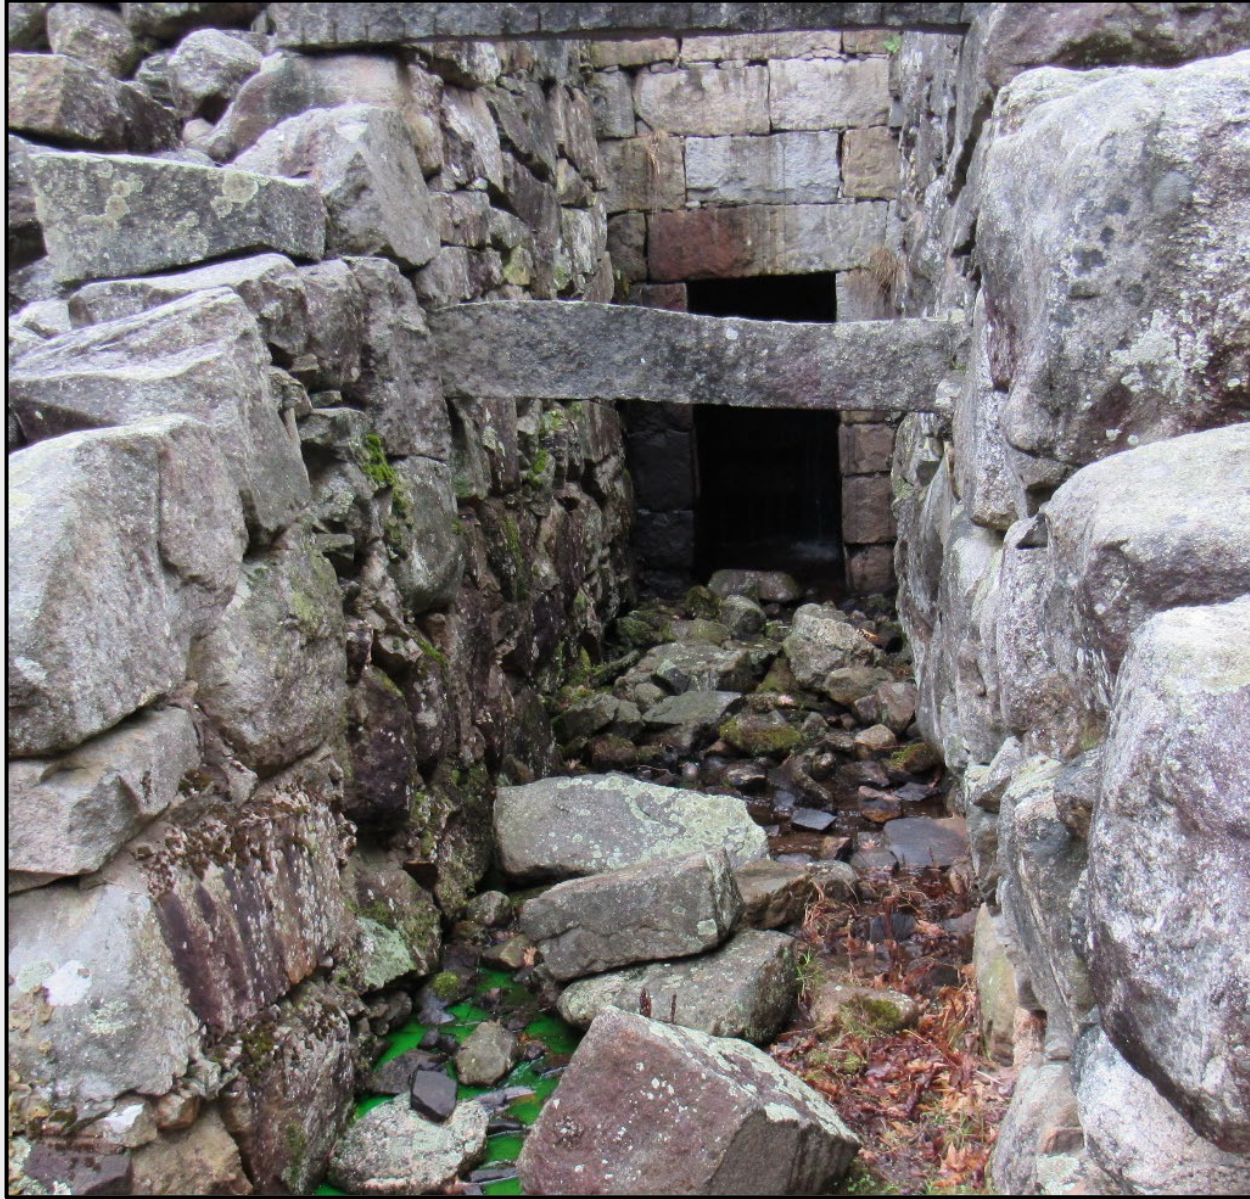
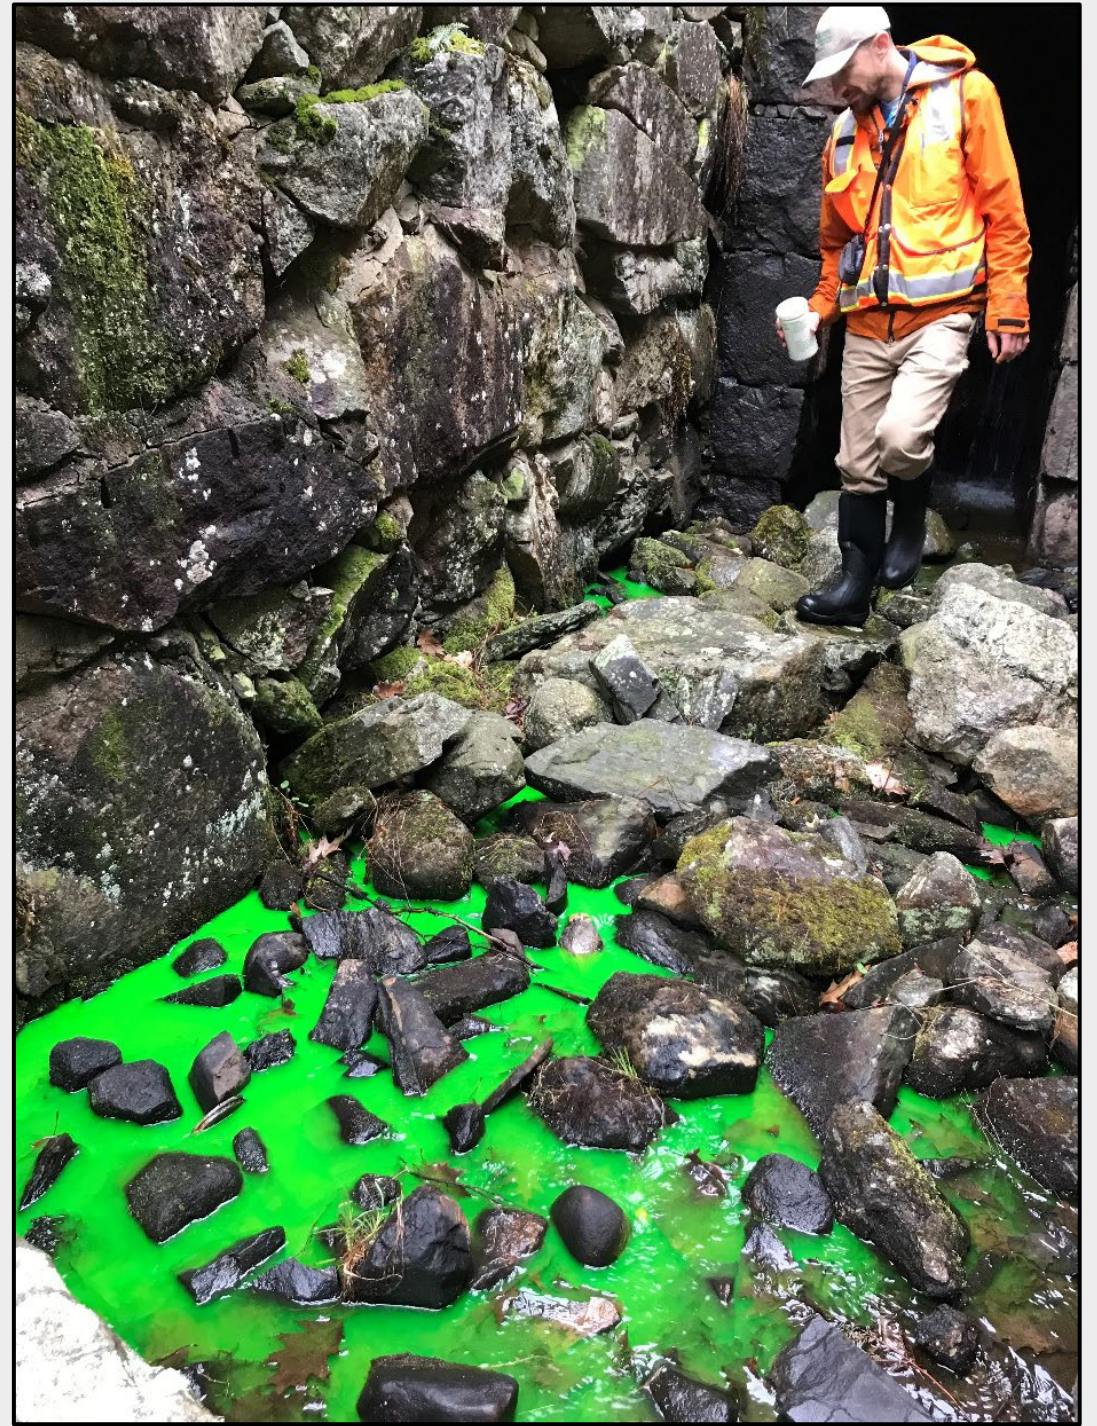
Dolloff Dam 2019

Gate Leakage

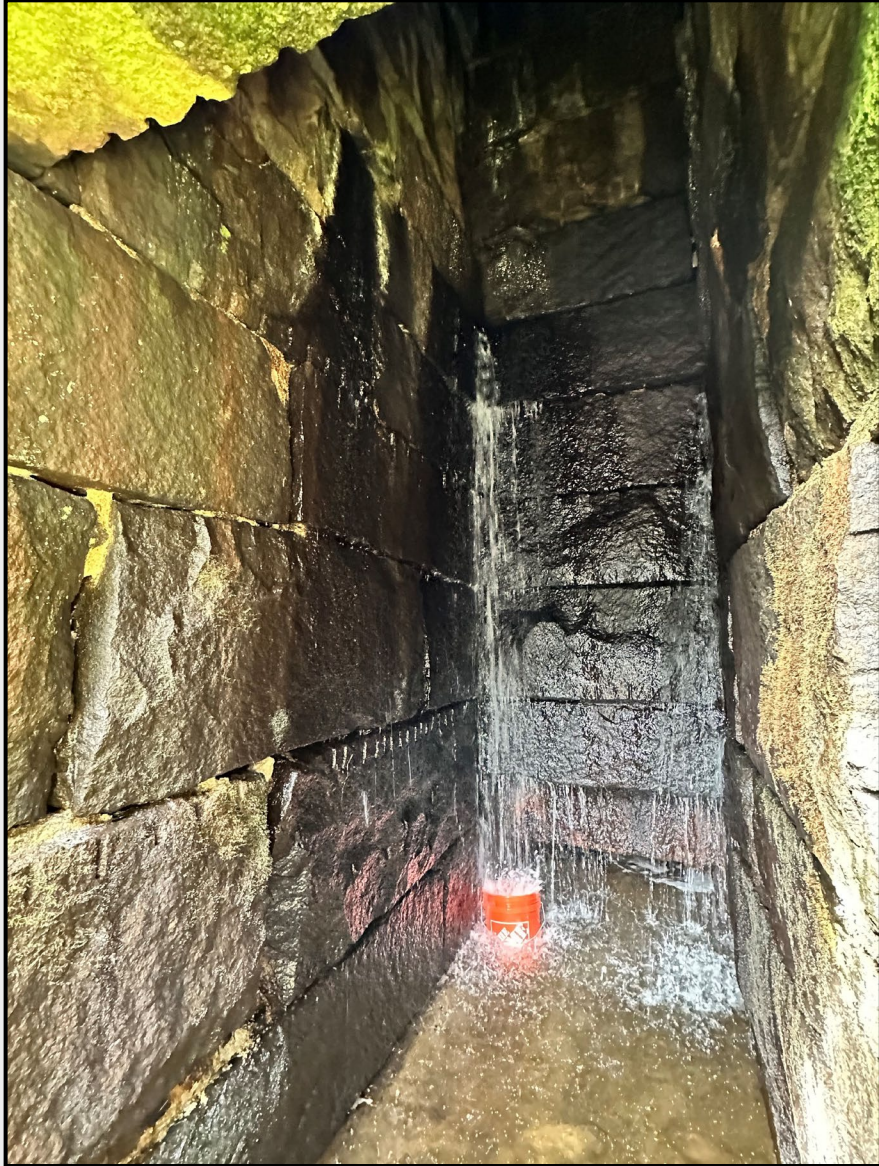
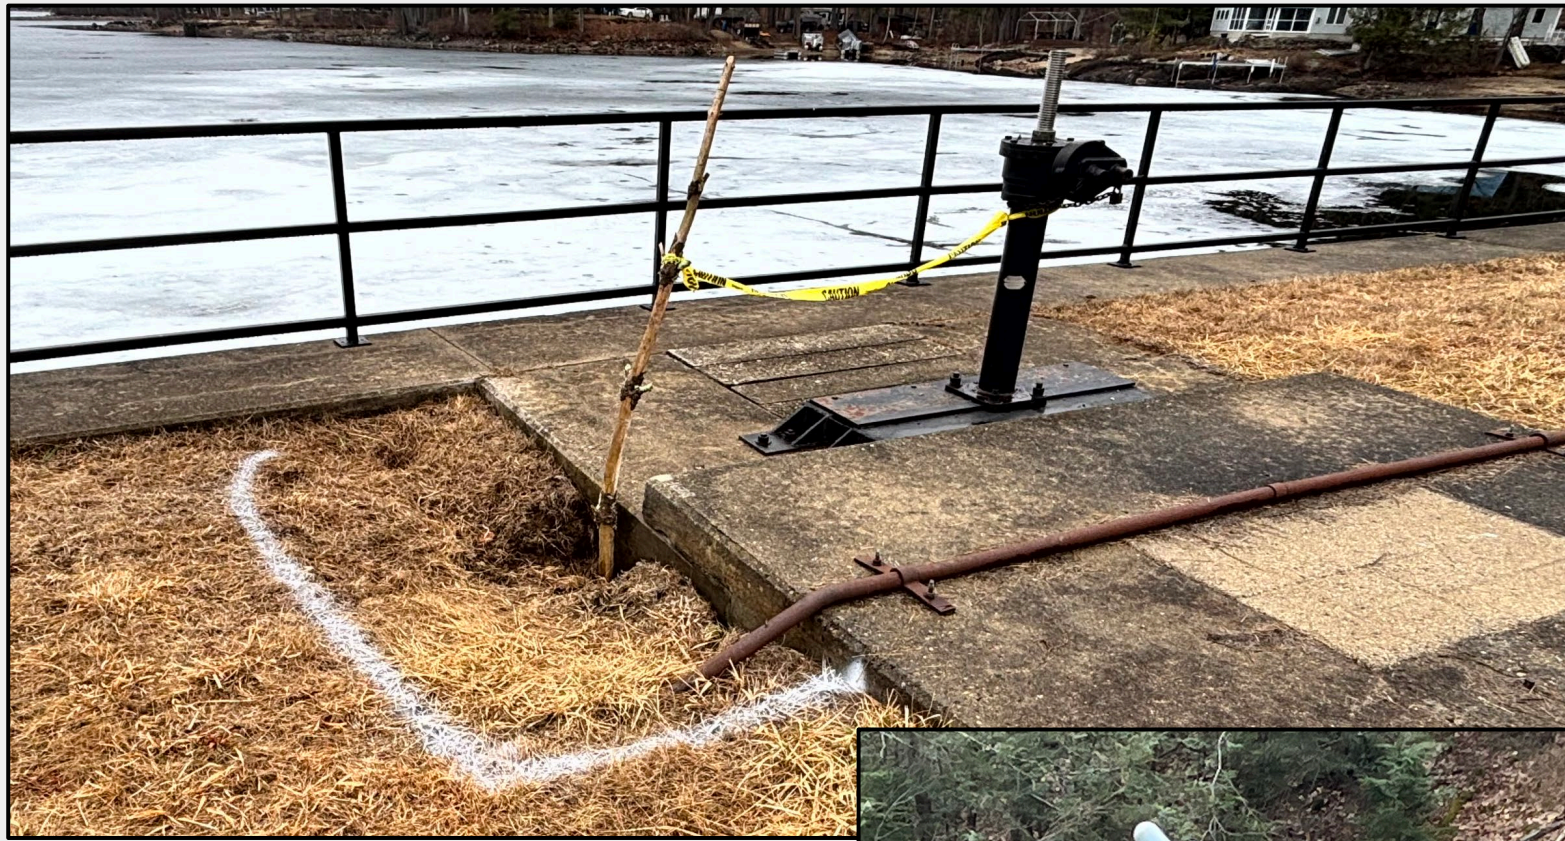
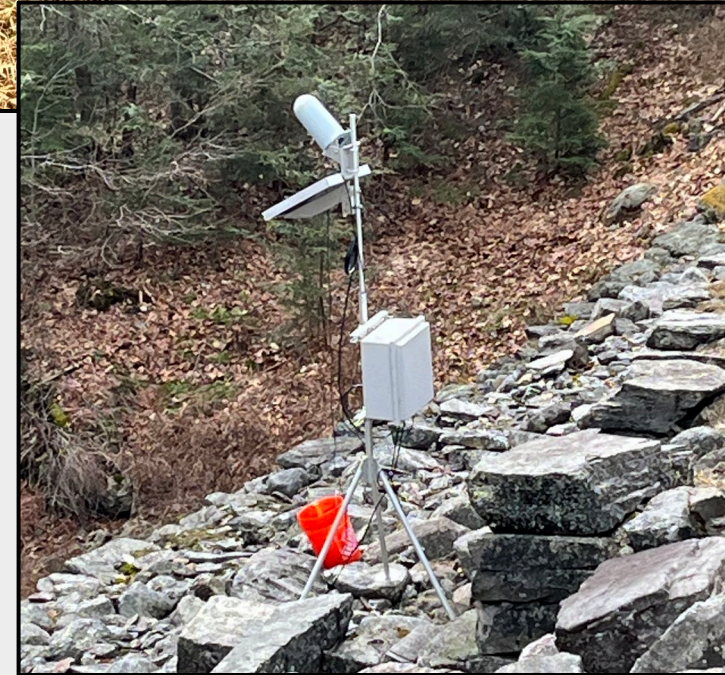
Dolloff Dam 2025

Sink Hole

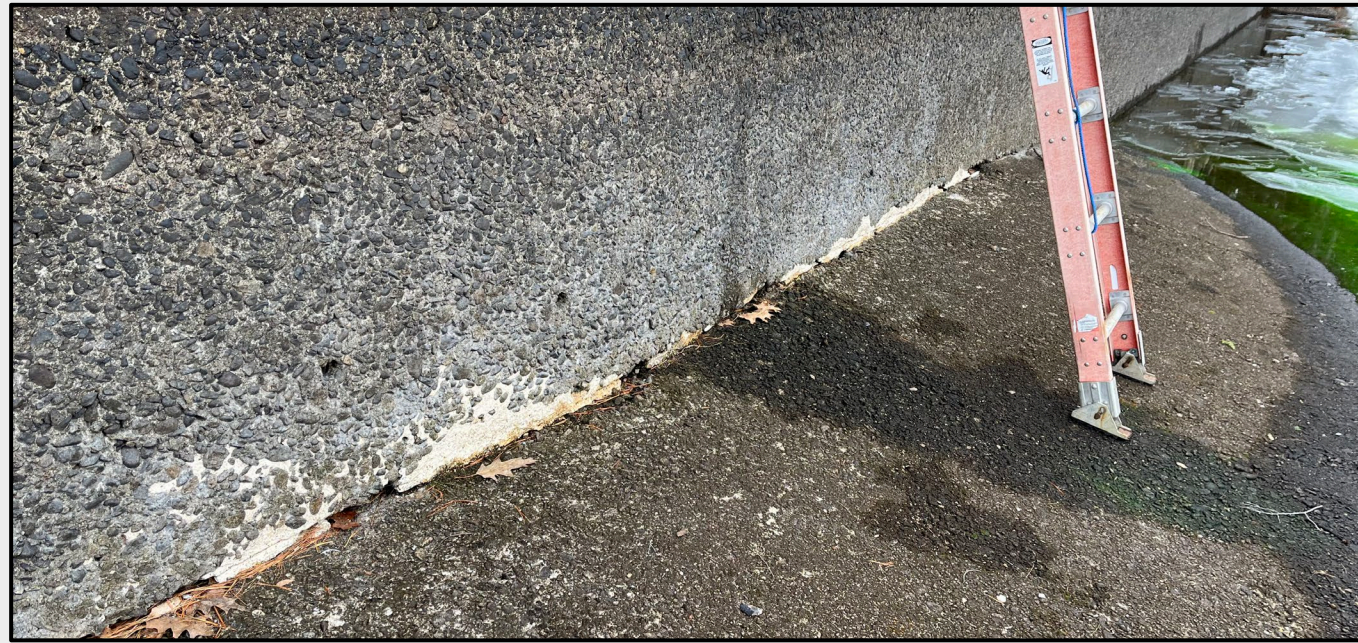
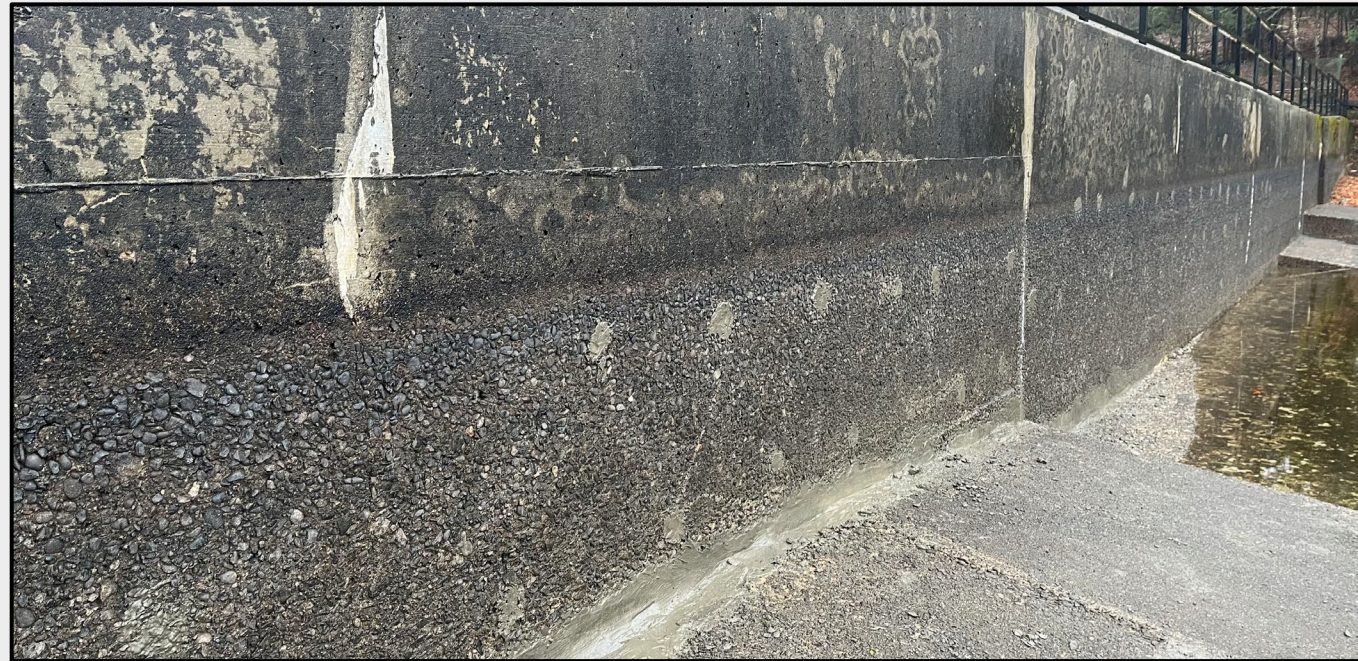
Dolloff Dam 2025

“Multiple locations of seepage through a horizontal crack, spalling, isolated poor consolidation, and open joints in the vertical shaft”

Repairs/Dive Inspection
