# »» FAQ BULLETIN ««

# RESTORING LAKE KANASATKA

Prepared by Laura Diemer, Certified Lake Manager, FB Environmental Associates  
in partnership with the Lake Kanasatka Watershed Association

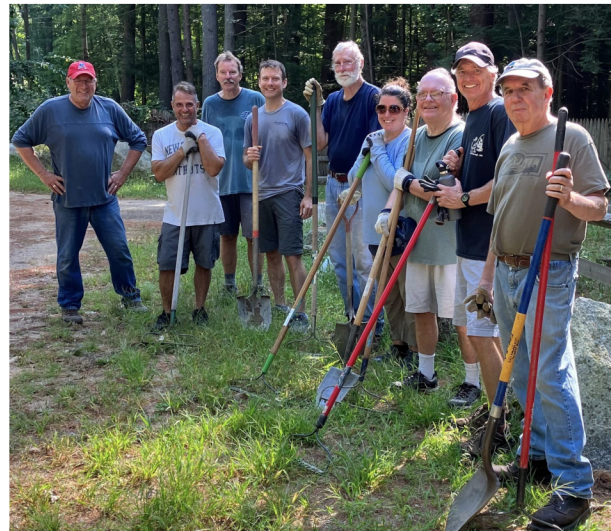
Excessive phosphorus inputs enter the lake in stormwater runoff from developed areas, especially from areas with minimal vegetative buffer, large areas of exposed, easily erodible soil, or poorly maintained roads. The best way to protect the lake is to divert runoff away from the lake to an area where the water can infiltrate into the soil. Local volunteers have done tremendous work already this year to help divert and infiltrate runoff and reduce the amount of phosphorus reaching the lake. In addition, LKWA submitted a \$100,000 grant request to NHDES to continue runoff improvements throughout the watershed. LKWA encourages all watershed residents to examine their own properties for possible runoff issues and become LakeSmart certified through the NH Lakes. Every small action to control runoff and other sources of phosphorus to the lake will help!

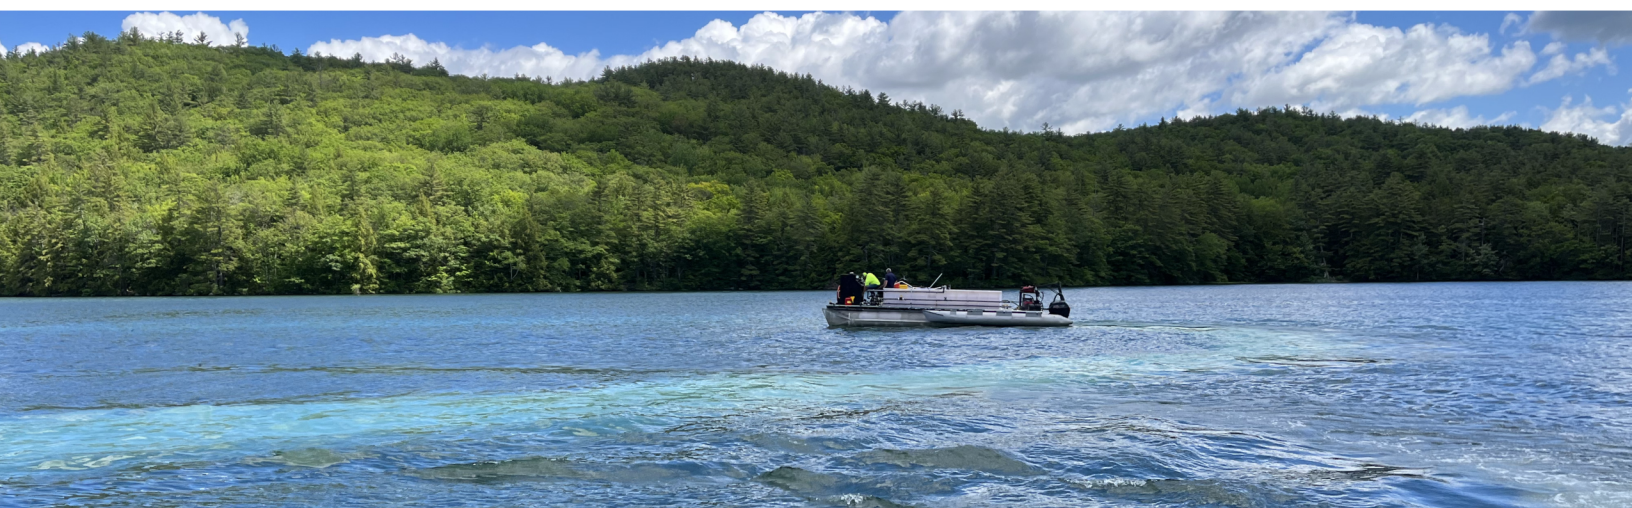
To treat a lake with alum, a qualified contractor adds alum into the lake to temporarily raise aluminum levels above the natural background. Alum comes in the form of a diluted mixture of aluminum sulfate and sodium aluminate, at low, safe levels. On a specialized 30-foot barge, the contractor uses a hose and tanks to inject the alum mixture, passing over the deeper areas of the lake once, twice, or more to achieve the needed dose. The alum then binds to dissolved phosphorus floating in the water column, creating a heavier solid called a "floc" – a fluffy, harmless substance made of aluminum hydroxide (the active ingredient in some over-the-counter antacids) that then drops down to the lake bottom and "locks" phosphorus so that it stays in the sediment even under low oxygen conditions.

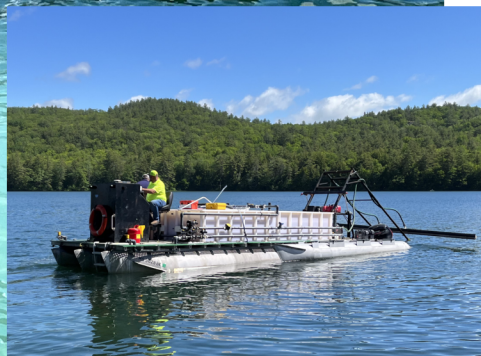
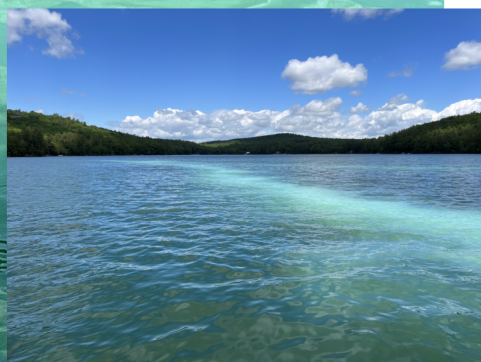
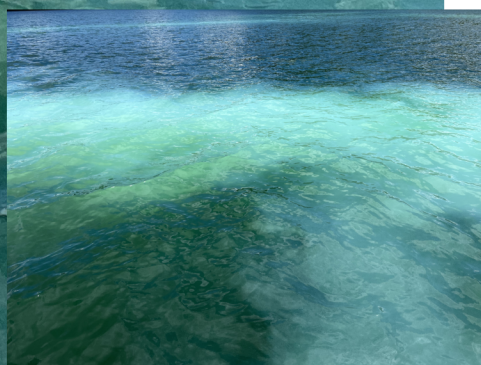
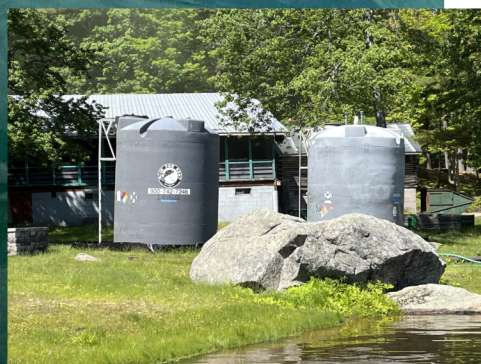
The contractor will arrive several days prior to the scheduled treatment (possibly as soon as mid-May 2024) to set up the staging area. The alum liquids are stored in large, shore-based tanks that require a flat, roughly 15 ft by 50 ft “staging area” that is close enough to the shore (within 200 ft) that a hose can fill the tanks on the treatment barge. The barge operator follows pre-programmed, GPS-mapped dosage areas to apply the alum at the appropriate rate until the tank empties. The barge operator returns to shore to refill and uses the GPS system to navigate to where they left off. This process is repeated until the treatment is complete. Because the dosing area for Lake Kanawatka is large, the treatment will likely take one or more weeks to complete.
